AN ASSESSMENT OF RURAL WATER SUPPLY SUSTAINABILITY IN MONZE DISTRICT, ZAMBIA

A dissertation submitted to the University of Bristol in accordance with the requirements of the degree of 'Master of Science' by advanced study in 'Water & Environmental Management' in the Faculty of Engineering.

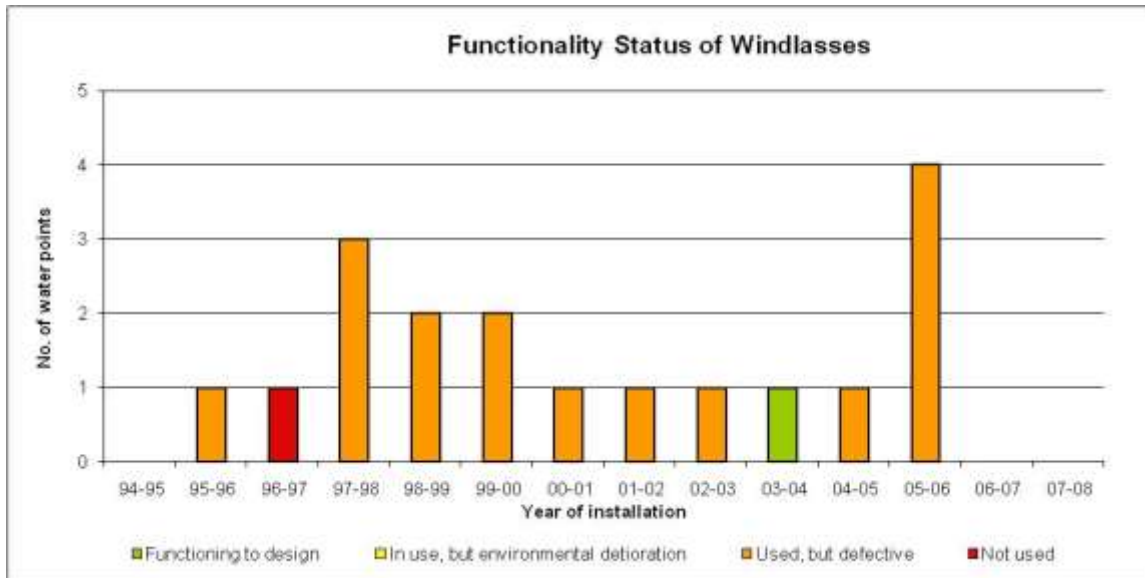
Figure 3: Functionality status of windlasses, by year of installation

Only two communities had carried out repairs to windlasses. In one village, the community replaced their wooden windlass, originally installed in 2003-04, with an improved metal one, which was easier to operate; and in the other, an individual paid for repair work following the collapse of concrete lining rings.

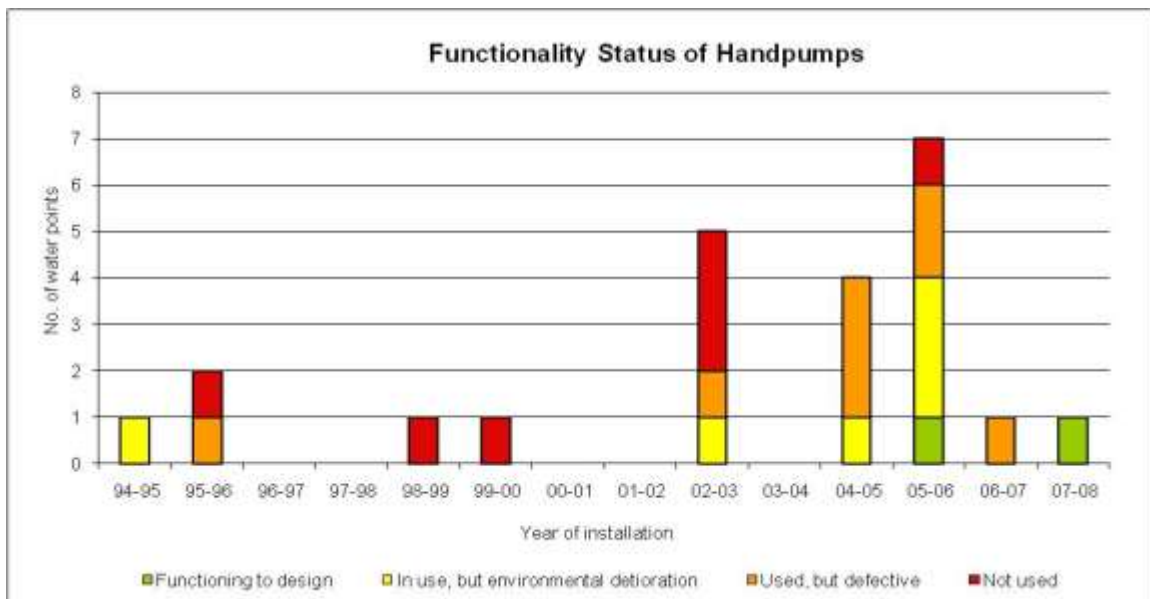
Figure 4: Functionality status of handpump, by year of installation

parts; and one handpump required a new chain but no money was available to pay for the part.

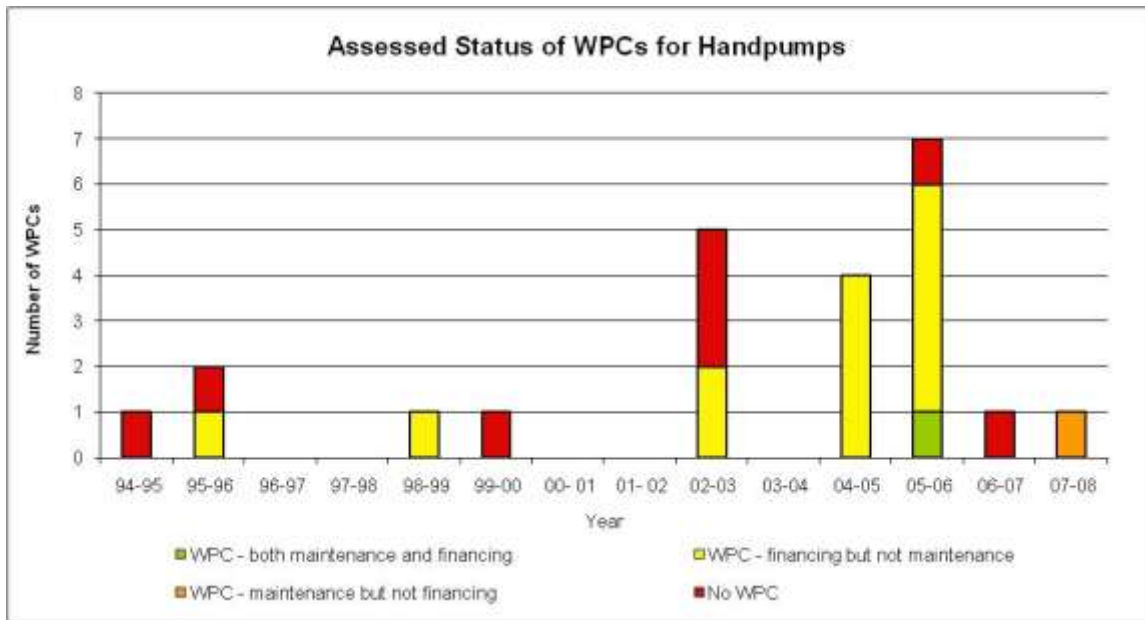
Figure 5: Water Point Committee Status, by year of establishment

WPCs were not operating at four non-functional handpumps. This includes three unsuccessfully installed handpumps where a WPC was never established. The other non-functional handpump had been out of service for more than a year. Failures to riser pipes had occurred on three occasions and the community had twice paid for replacement parts. After a third failure, the community were unwilling to pay for more repair work.

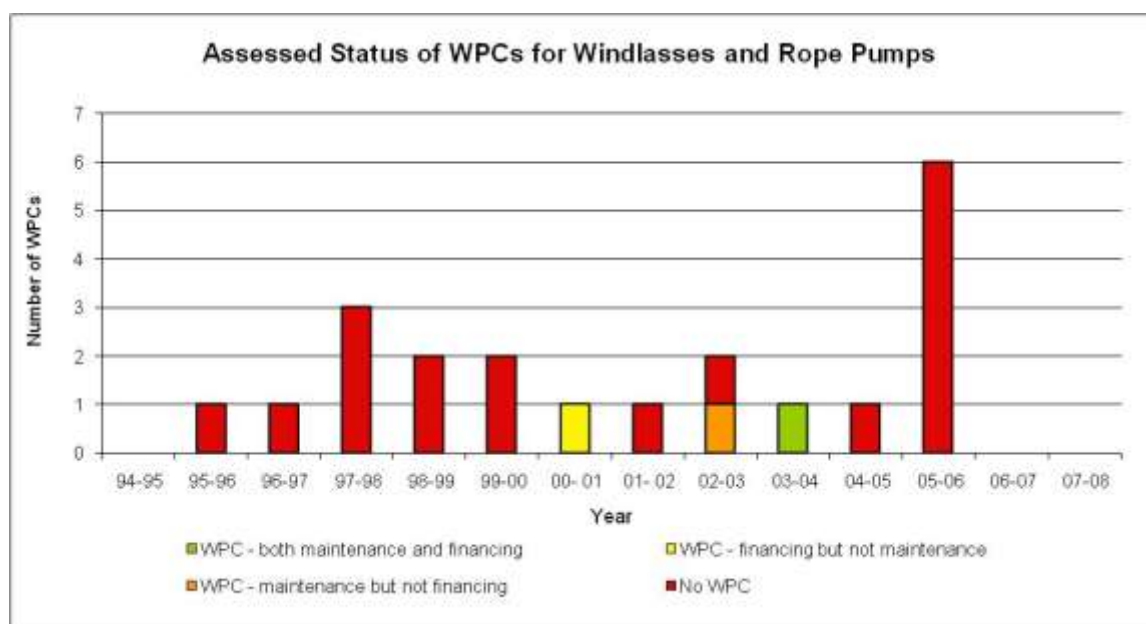
Figure 7: Water Point Committee Status, by year of establishment

The vast majority of windlasses, and all rope pumps, had no WPC managing the service. As with handpumps, communities reported that over time, WPCs ceased to fulfil their responsibilities. A far greater proportion of WPCs for windlasses (as compared to handpumps) were no longer operating. Figure 7 presents the status of WPCs, by year of establishment.

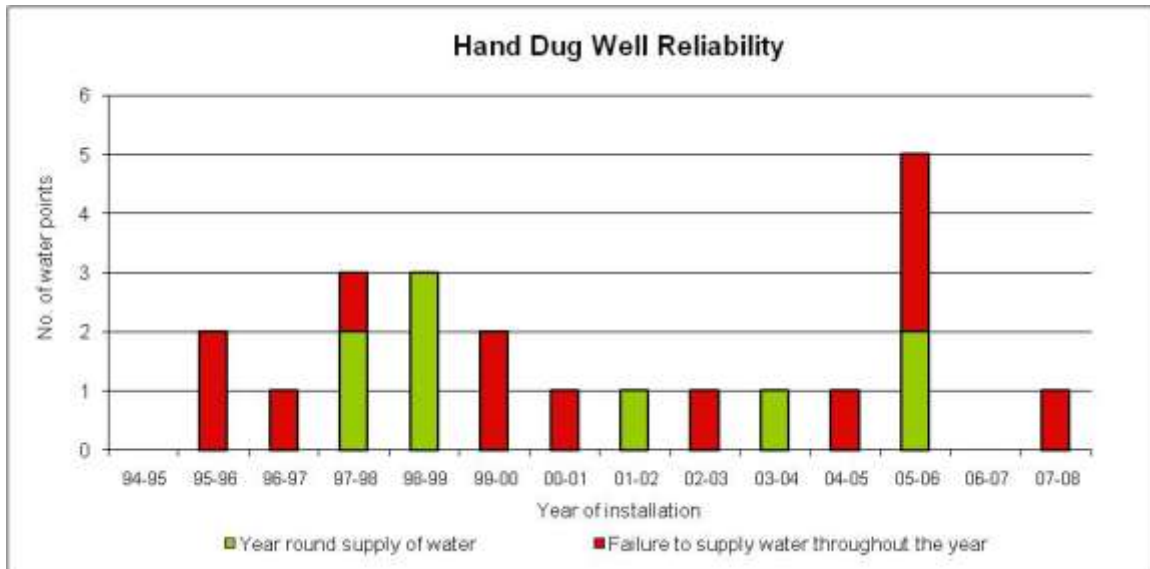
Figure 8: Hand-dug well reliability, by year of installation

Between November and January, when water levels are at their lowest, 11 hand-dug wells fail to provide access to water. Communities reported that as the wells were being constructed, digging ceased when water was reached, which could be a key factor influencing their reliability. No village reported the use of a dewatering pump during construction. Figure 8 shows hand-dug well reliability by year of installation; 9 (45%) were reliable.

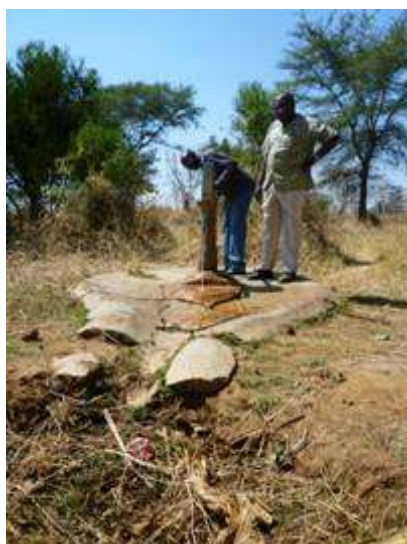
Both the hand dug well and the borehole provide reliable sources of water to households accessing them throughout the year. However, only 13 households used the HDW and only 5 accessed the handpump. Twelve other households used a water point located in a neighbouring village, whilst the remaining households used unimproved water sources.

As can be seen from the photographs, the windlass was not operating and people accessed water by using their own ropes and buckets. The windlass was apparently stolen shortly after installation and has not been replaced. The handpump has never broken down or required any remedial work. The borehole is 49.50 metres deep, and the water level was recorded as being 8.3 meters. No protective fencing exists, the apron is badly cracked and the soak away facility uncared for.

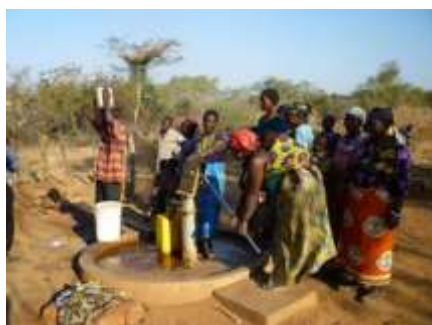
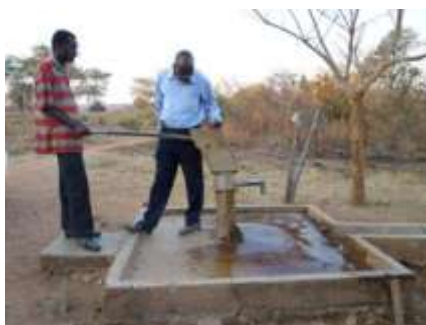
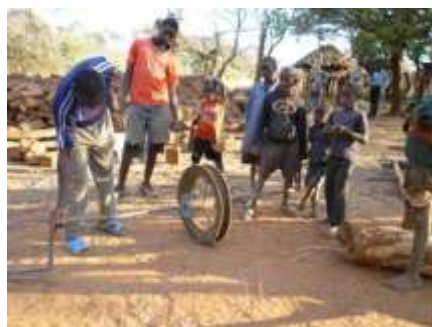
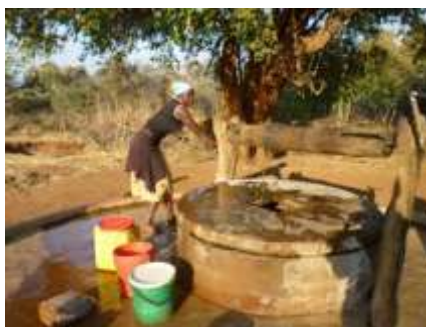
The hand dug well does not provide a reliable source of water. Between October and January, when water levels are at their lowest, the source 'dries up'. In 2002-03 the original windlass system was removed from the hand dug well and replaced with a rope pump. However, the rope pump suffered continual failures and the community decided to re-instate the windlass due to its superior performance. The

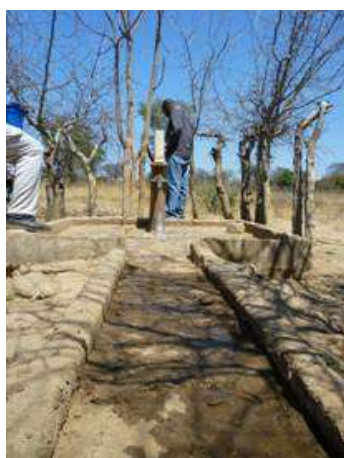
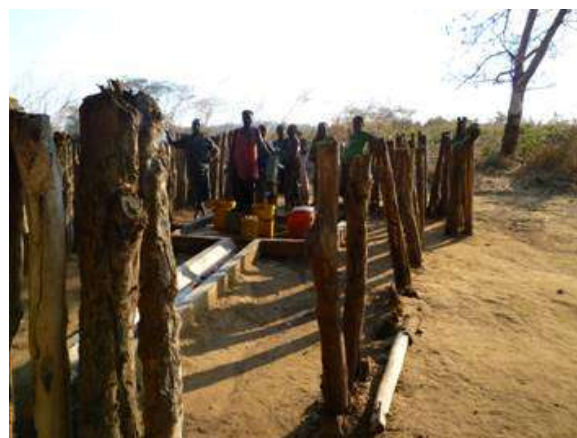
The WaterAid supported borehole does provide a reliable source of water. However, the older facility does not; between October and January, when water levels are at their lowest, the source 'dries up'. In the photographs above, the older facility is A and the WaterAid supported one is B

Both facilities have independent WPCs. The WaterAid supported facility collects ZK1000 / HH / year while households using the older facility contribute ZK5000 / HH / year. Not all households pay all of the time however. Only ZK82,000 is in the maintenance fund for the WaterAid facility, which is insufficient to cover the cost of replacement pipes. The maintenance fund for the

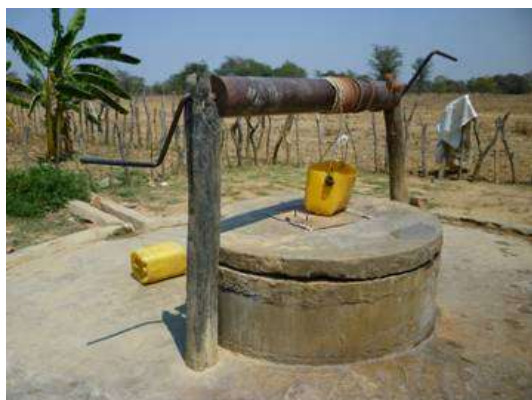
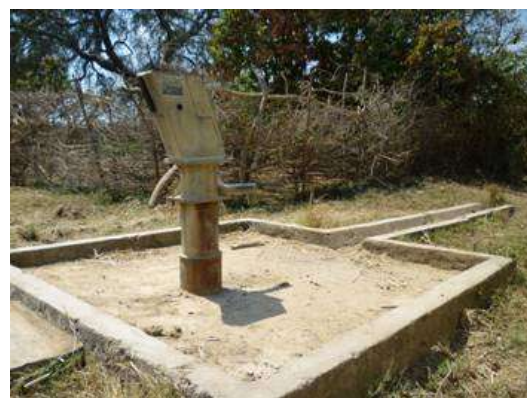
The WaterAid supported HDW provides reliable access to water. The WPC coordinated the management and financing of a replacement (and improved) windlass facility, paying a local welder to manufacture a metal cylinder. There's a well constructed fence, clean surroundings and effective soak away which waters a small banana plantation. 13 households regularly use the facility, but when neighbouring handpumps fail, more people use it. A rope pump was fitted to the facility, but was removed within a year of installation due to continual breakdown.

The borehole used to provide reliable access. It was 60 metres deep and water was first encountered at 3 metres. However, at the time of visit it was not functional. 60 households from 3 or 4 villages used the water point, and all were supposed to regularly contribute. The facility suffered two failures, the first associated with damaged pipes, however they could not be afforded so the damaged pipes were removed and discarded. The second and fatal failure was the chain. This has not been replaced and consequently the facility remains out of action. Lately, spare parts for a nearby school pump have been taken from the handpump, including the handle. There is no WPC for the handpump, however there did use to be one. Some questions were noted regarding the

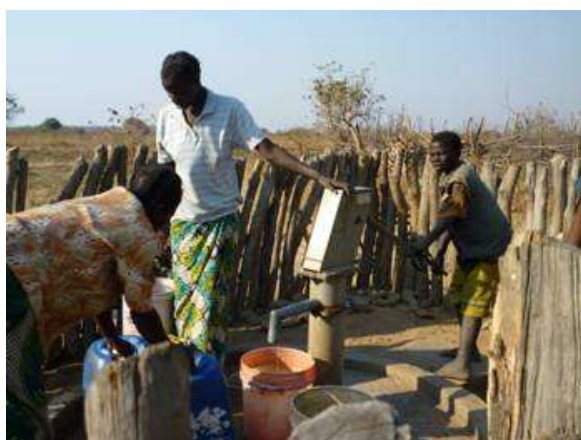
The facility provides reliable access to water throughout the year. The area surrounding the water point is well maintained and the protective fencing offers a resistant barrier to unwelcome guests. All 22 households within the village access their water from the handpump. Five households from neighbouring villages also use the facility, and a school borehole is also accessible.

The WPC collects ZK10,000 from the 27 households accessing the facility, however some are not always able to pay. The handpump is yet to experience a failure.

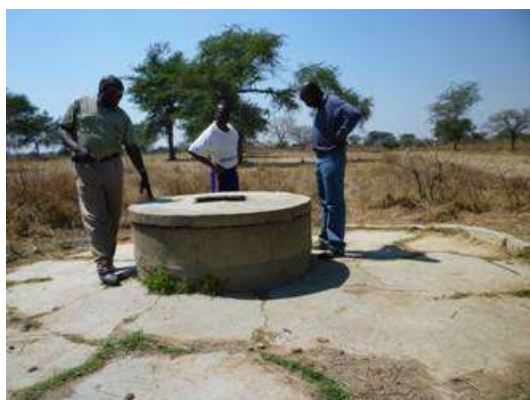
None of the facilities supported in Hamwaala ever functioned. The HDW was constructed by the community who dug until they reached an impassable rock. Even though there was not much water in the well, they lined the facility after collecting cement from the local clinic. No one came to check the well prior to lining work commencing.

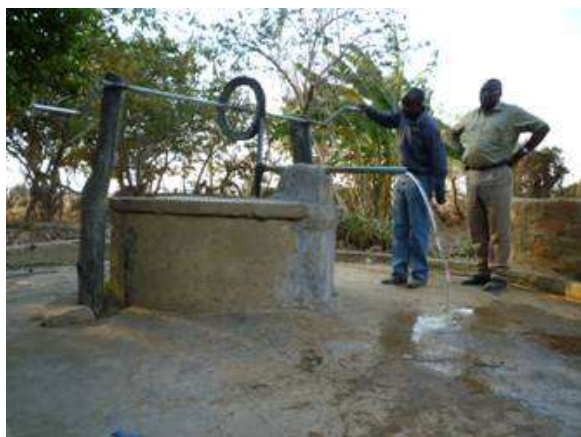
WaterAid supported construction of a HDW in 1998-99 which was subsequently rehabilitated 2005-06. The original windlass system was replaced with a rope pump which the community continue to maintain. Reliable access to water is provided throughout the year. No WPC exists for the facility, however it is contained within a garden plot so is securely fenced and protected from animals. Individuals who use the garden also ensure the surroundings of the water point are clean. The rope

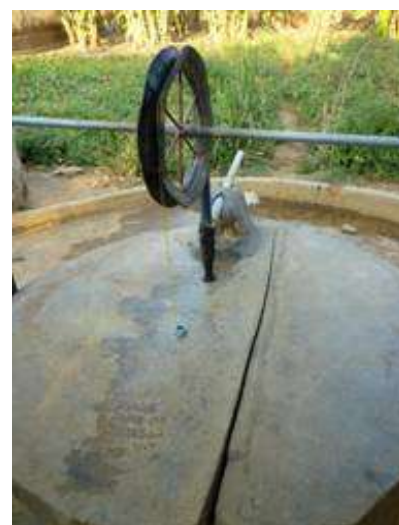
pump has failed many times and repairs are undertaken by one individual within the village. Initially, households contributed towards the repair however no structure for recurrent funding was in place at the time of visit.

The community additionally stated that households using the rope pump to support gardening initiatives viewed the facility quite favourably as modifications to the system allowed easy irrigation of their plants. However, households relying on the water point for domestic purposes were less enthusiastic about the service provided by it.

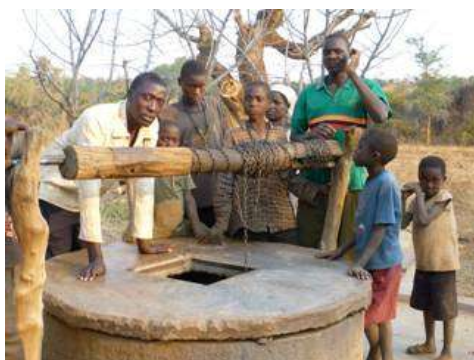
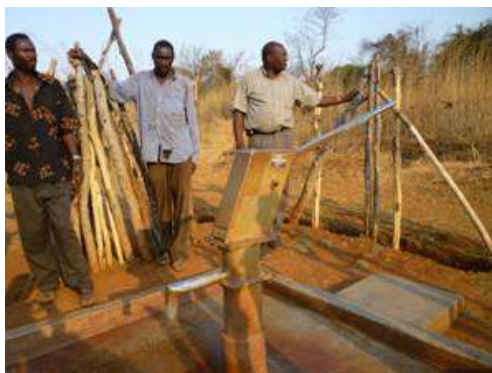
The rehabilitated HDW provides reliable access to water for nine households and has never suffered a breakdown. Although the windlass system is in place, no bucket is attached to the chain; individuals employed buckets and ropes to access water. Cracks in the surrounding apron were reportedly permitting surface water to enter the well. No WPC for the facility exists and no recurrent funding mechanism was operational at the time of the field visit.

A borehole supported by DAPP had been installed but never worked. It was unclear why WaterAid had not undertaken a rehabilitation of this facility rather than installing a new system. Apparently DAPP have been contacted many times over the 13 years since the handpump was unsuccessfully implemented but to date are yet to rehabilitate it.

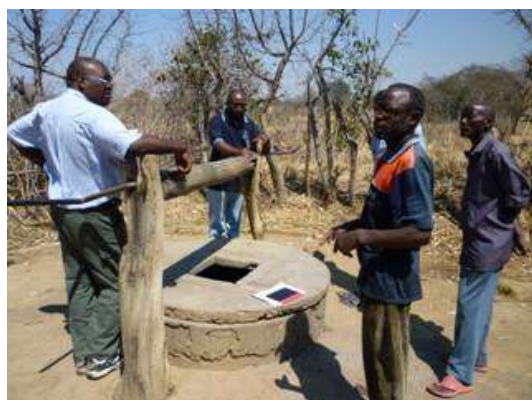
The WaterAid supported HDW does not provide reliable access to water for the community. During the time of year when water levels are at their lowest, no water is available. Although the windlass facility is in place, no chain or bucket are attached as households access water through individual ropes and buckets. No WPC for the facility exists, however one individual within the village managed a repair to the system. Lining rings in the well collapsed and he paid for

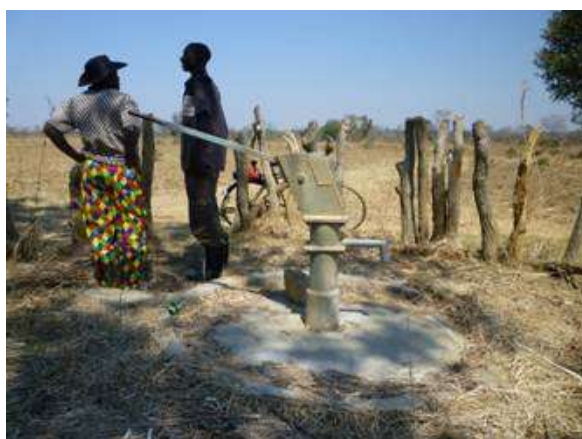
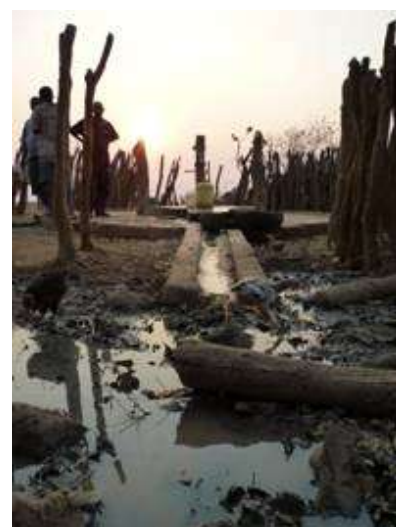
WaterAid supported the rehabilitation of two facilities within Sihubwa. Photograph A relates to the first water point, which was not functional at the time of the field visit having failed in November 2008. Three new pipes were required for the handpump, however insufficient money existed to cover their purchase and consequently, the water point has remained out of action ever since. The WPC was apparently still operational, but did not have any roles to perform; recurrent

HDW was rehabilitated and Afri-dev handpump installed, which provide reliable access to water for the 67 households that rely upon it. It is a coincidence that 67 households use this facility as apparently none are from the village of Sihubwa; the distance to it is too great for people to journey multiple times each day. To date, no failures have occurred to the facility. No WPC exists to support its management or maintenance. The protective fencing is inadequate and the soak away facility unproductive. No recurrent financing mechanism is in place. This was the only Afri-dev handpump witnessed within sampled villages and users were unclear how they would access spare parts in the event of system failure.

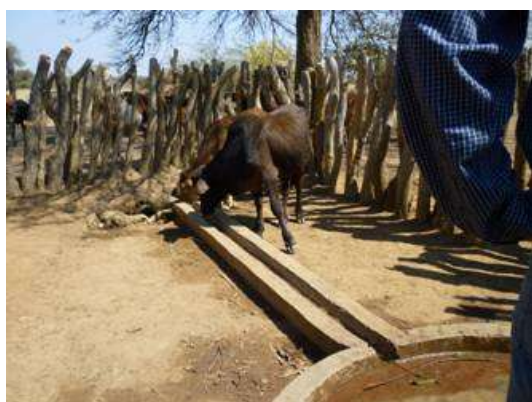
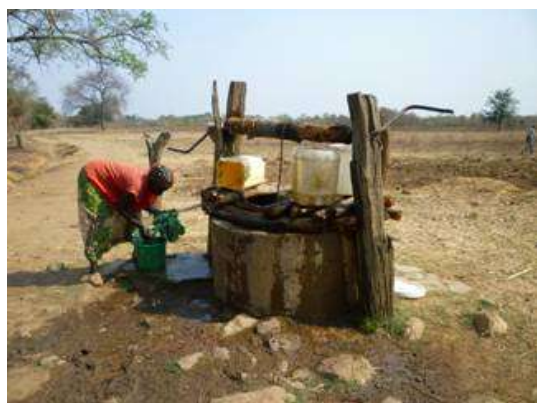
Both the HDW and borehole provide reliable access to water. There is no WPC for the windlass facility, which has suffered one breakdown since it was installed; the cement lid on top of the well opening has collapsed and fallen into the water. A make-shift lid has been constructed of wood, no attempt has been made to organise a replacement or to remove the broken lid from the water. There is no protective fencing for the facility, nor a cement surround and soak away.

Protective fencing for the handpump facility could be improved, as photograph A demonstrates. The facility has a functioning WPC who collect recurrent contributions, however as demonstrated within the main report, recurrent financing is not good. The handpump has suffered one breakdown, which related to damaged pipes. Replacement pipes were provided free of charge by DAPP. All 45 households in the village access the facility and it is additionally shared with several households from a second

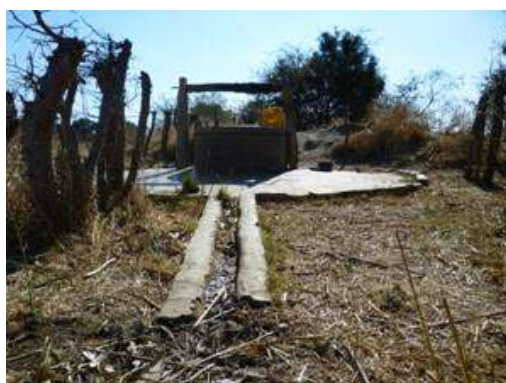
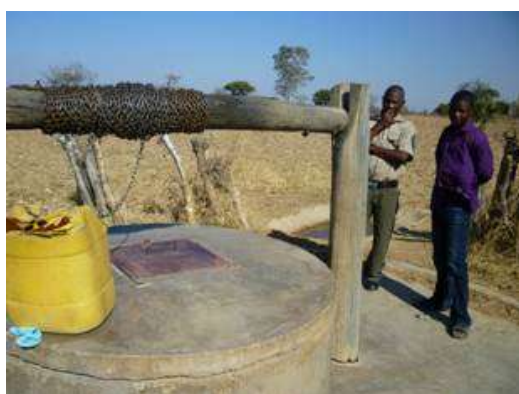
The WaterAid supported HDW and windlass were functional and in use. However, the well did not provide a reliable source of water to dependant households, failing when water levels were at their lowest. The facility was clean, however almost no protective fencing remained and the soak away facility was unproductive. No WPC exists for the HDW and no recurrent financing structure is in place to generate and collect funds for maintaining the system. 25 households use the water from the 56 within the village. Additionally, nine households from neighbouring villages also access water from the well. The water point provides water for cattle, however brick making enterprises are not supported by it.

The handpump facility was not implemented with WaterAid support. The facility failed in 2007 and is yet to be repaired. The handpump has a long history of failures, with some households within the group suggesting it could have experienced as many as 20. Pipes were the cause of many breakdowns and were the reason for the current non-functionality. Previously households have purchased replacement pipes for the system, but were unwilling to invest more money to repair the system again. Households previously accessing water from the handpump were now reliant upon unimproved sources. With 56 households in the village and only one functioning water point, coverage in Hambalamatu was 45%.

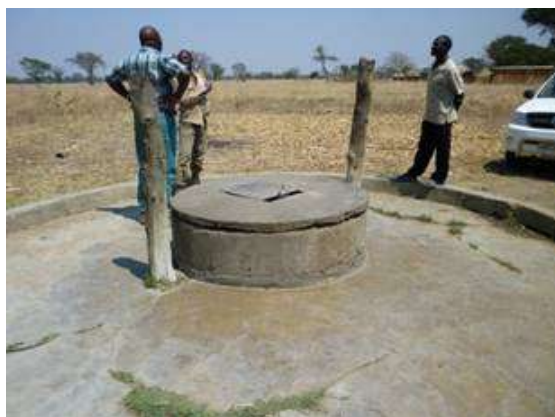
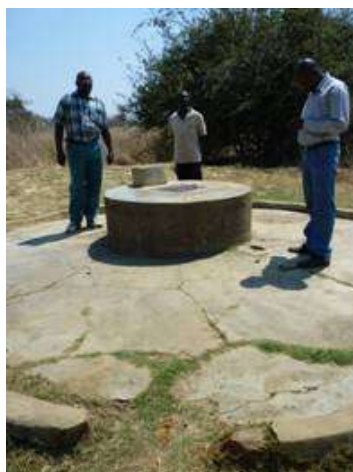
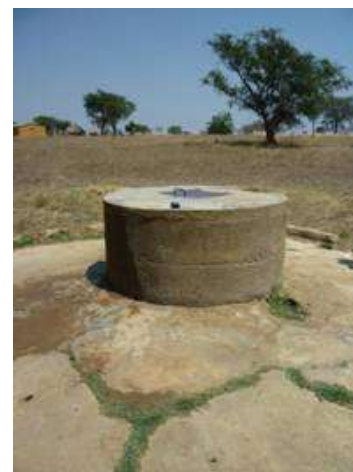
WaterAid supported the implementation of all three HDWs in Sintambo, and all provide reliable, year round access to water for dependant households. However, none of the windlass facilities have been maintained; all have deteriorated and not been replaced. In all cases, households were accessing water using individual ropes and buckets. None of the water points had protective fencing, and all the surrounding aprons were cracked. None of the facilities had a WPC and no recurrent financing mechanisms were operational.

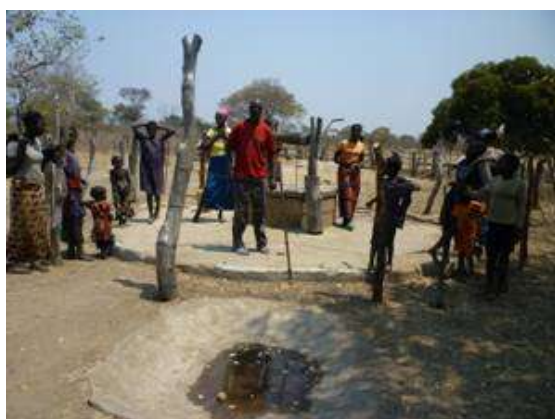
WaterAid supported the implementation of a HDW and windlass in Kabuyu, which does not provide a reliable source of water throughout the year. At a nearby farm, an old borehole does provide year round access but the facility has severely deteriorated and an improvised handpump constructed of wooden beams is used to access water in the well.

The windlass system remains in use and no failures to it were reported by the group. A WPC is in operation and undertakes cleaning of the facility as well as maintaining the protective fencing. Materials used for fencing include barbed wire which prevents access by cattle, but many dogs, goats and chickens were observed around the water point during discussions. No money is currently collected for the HDW facility. 20 households use the water point from Kabuyu and an additional 5 households from neighbouring villages also access water from the well. It was stated that in addition to domestic use, cattle are also watered from the facility.

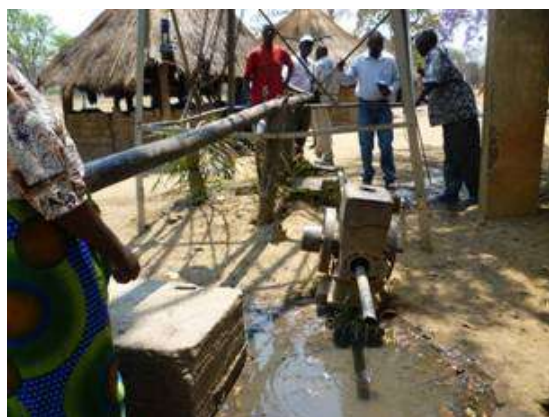
The old borehole was installed by the original owner of a farm. It was previously attached to a pump driven by a windmill, however over time, the mechanism has failed and not been repaired. A WPC for the facility exists and in addition to maintaining the locally manufactured pump, collects money for maintenance of the facility. Many of the

households using the HDW contribute to maintenance of the borehole, although it was made clear that money collected for the borehole could not be spent on the HDW. Five households regularly use the facility however this number increases when the HDW fails to provide sufficient water. No cattle or brick making facilities are supported by the borehole.

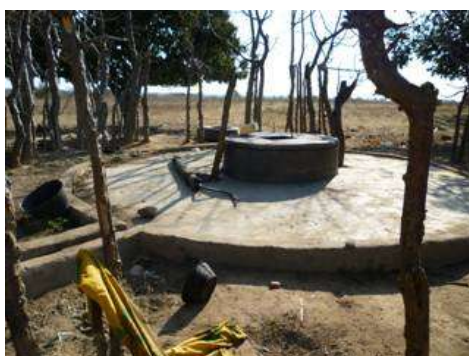
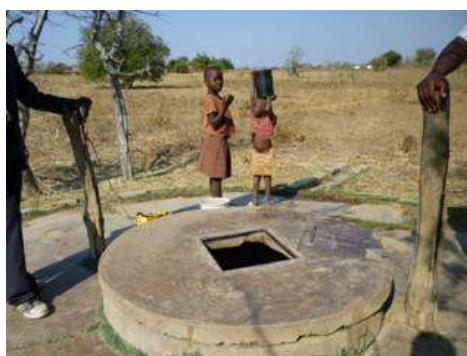
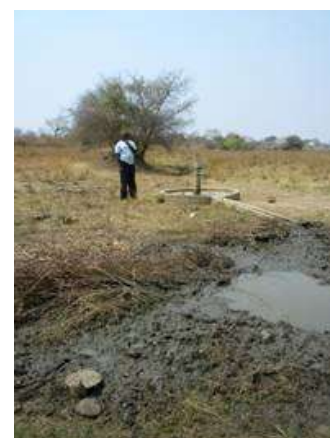
The two HDWs supported by WaterAid do not provide access to a reliable source of water for dependant households. In both cases, the windlass facility has deteriorated and not been replaced; households access water using individual ropes and buckets. Neither water point has a functioning WPC and no funds are collected to support repair and maintenance activities. The protective fencing of the water points was ineffective, the closable flaps missing, and the aprons were cracked. Collectively, it was reported that only 22 households accessed water from the facilities, although 6 households from neighbouring villages were also regular users of the water points. Additionally, when handpumps in neighbouring villages failed, the number of people using the HDWs also increased. In both cases, cattle were also watered from the wells.

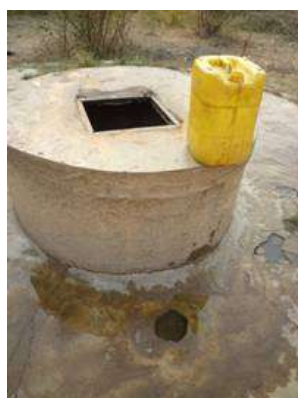
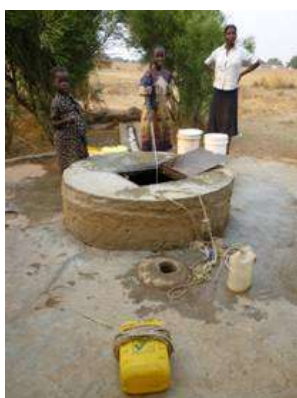
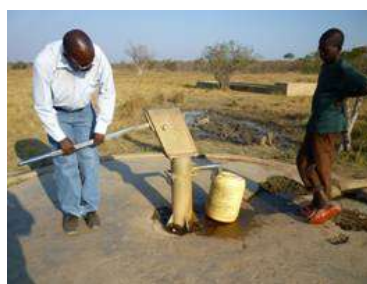
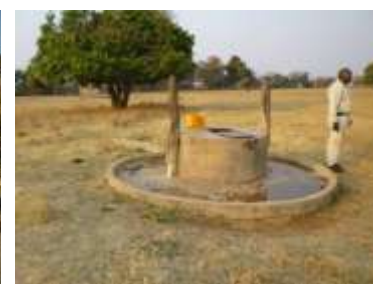
WaterAid supported rehabilitation work to four facilities in 2005-06. None of the HDWs provided households

with a reliable source of water throughout the year. And none of the windlass facilities had been maintained; all households were using individual ropes and buckets to collect water. None of the water points had a functional WPC and no recurrent financing mechanism was operational for the HDWs. In total, 38 households were using the three HDWs from Chicheleko, but it was reported a small number of neighbouring households also accessed water from the wells. Cattle were being watered from all of the wells.

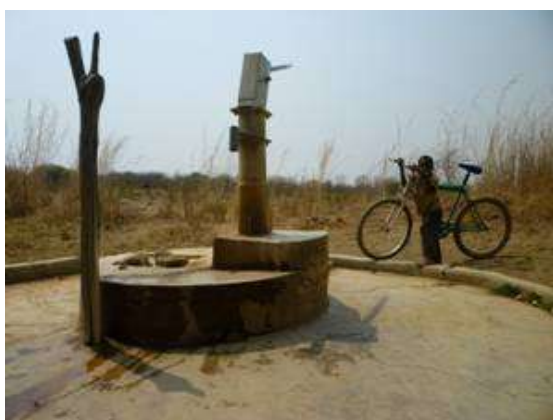
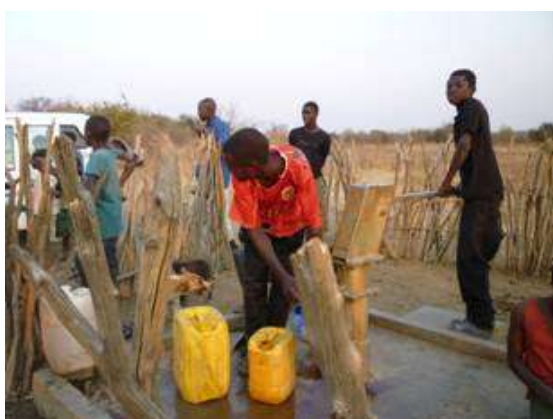
Initially, a HDW with windlass was supported by WaterAid. However, the facility did not provide reliable access to water. The well was 30 metres deep, and could not be manually excavated beyond that depth. In 2002-03, the facility was rehabilitated and a handpump was installed. However, the well was not deepened at this time so continued to provide unreliable access to water. As it may be possible to note from photograph A, the well lid also houses a lid that enables households to use buckets and ropes to access water; this was apparently installed to facilitate access in the event of handpump failure. Having an unsealed well however means the water is open to sources of contamination. No WPC exists for the facility, which has never broken down. No protective fencing surrounds the handpump.

It was reported that only a very small number, if any, households use that facility however. In 2005-06 a new borehole and handpump were installed approximately 400 metres from the older facility. It was unclear why rehabilitation work to the existing handpump had not taken place. The new handpump does provide reliable access to water; however

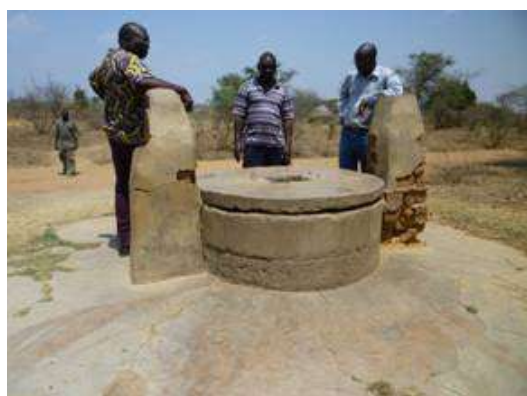
The WaterAid supported HDW apparently never had a windlass mechanism provided, despite brick supporting structures being constructed. The facility does not provide a reliable source of water for dependant households and individuals access water using ropes and buckets. No WPC exists and no recurrent funding mechanism is in place. No protective fencing exists, the apron is cracked and the soak away does not perform well. Cattle are watered from the

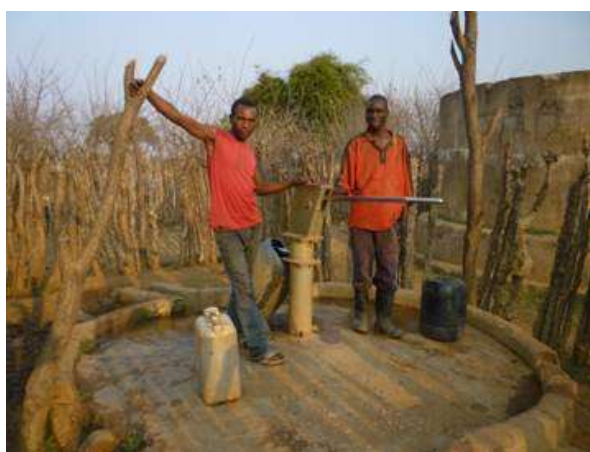
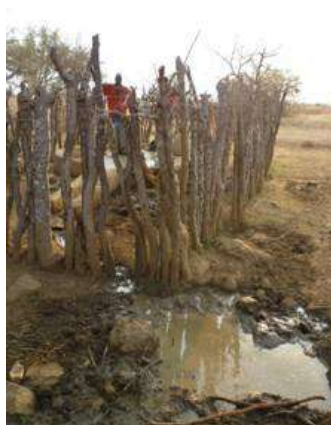
The rehabilitated borehole provides reliable access to households throughout the year. Prior to rehabilitation work, the facility was originally a windmill driven system which deteriorated and was replaced with a handpump in 1994 by Afri-care. WaterAid rehabilitated the facility 10 years later, by providing a new handpump.

A WPC for the facility exists and collects funds from households on a regular basis. However the level of funding is insufficient to cover the cost of necessary works. The handpump has failed at least six times due to damaged pipes, and in each case, the offending pipe has been removed and discarded, rather than replaced. Originally, 12 pipes were attached to the handpump, currently only 6 remain.
