# Female-friendly public and community toilets in India: an assessment of a central Indian city

May 2022

In this context, WaterAid India conducted an assessment of public and community toilets in a central Indian city,<sup>2</sup> with the objective of understanding the needs of female users in accessing and using these facilities, and the challenges they face.

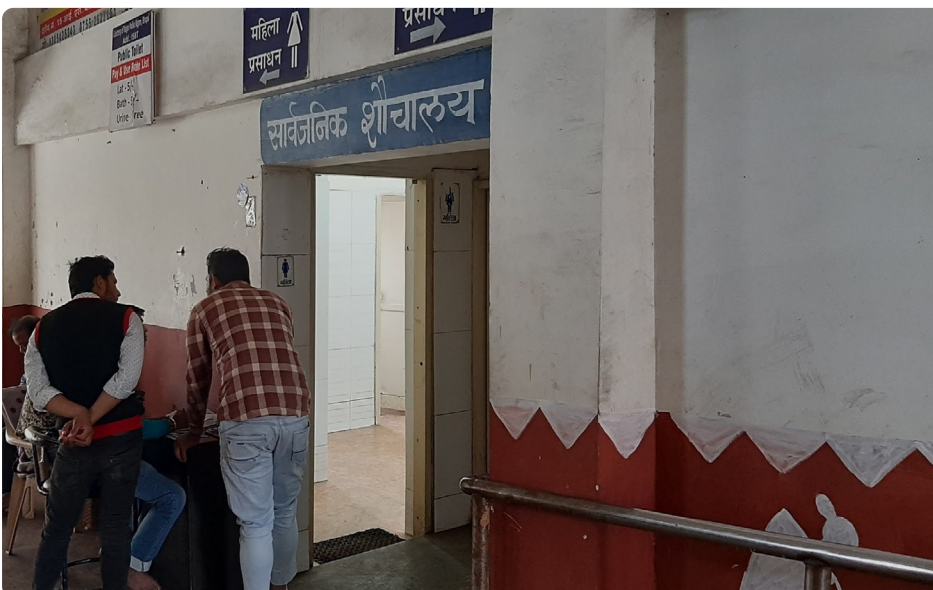
◀ **Photo 1:** Public toilet at the bus terminal showing signage and separate entrances with no doors. The picture also shows men gathering by the entrance, which can be intimidating for female users.

- All toilets should be easy to locate with **clear signage**.
- Add public toilet facilities to **online map** services to make them easy to search for and find.
- Assign a **female caretaker** and cleaner in female sections.
- Caretakers should make sure that the doors of male toilet blocks are closed to **maintain privacy** for female users. Future designs should consider privacy in the location of the different sections of the toilets.
- Fixtures such as dustbins and sanitary pad vending machines should be located such that they can be used without compromising privacy.
- The **She Lounge** creates a safe space for women who do not have access to a toilet in their workplace. This initiative should be replicated at other locations in the town.
- Ensure that entrance doors have **door handles on both sides** for security and ease of use.

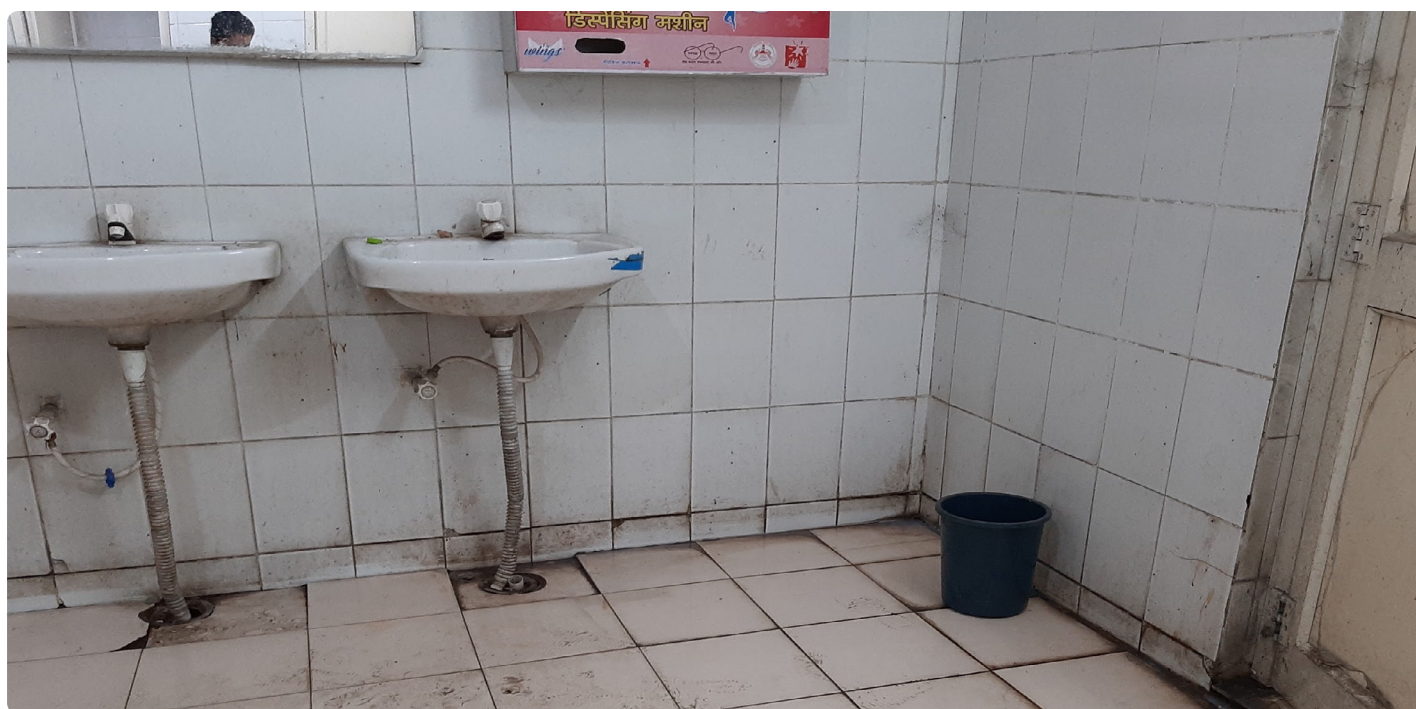
▲ Photo 2:

A handwashing area at a public toilet at a bus stand with a mirror. The presence of soap was not common in the study. Whilst bins were often present, they did not have lids and were not always well-maintained

- Install **soap dispensers** in all toilet blocks and maintain regular checks to keep them filled. Alternatively, soap strips could be used as an affordable alternative for users who do not wish to use the dispensers.
- **Hooks and shelves** should be installed in the toilet cubicles, urinal and bathing units.
- **Information posters** could be used to give guidance on using the sanitary napkin vending machine, disposal options (including incinerator where available), and other more general information on hygiene. These should be picture-based and simple so that women can understand the information without having to seek clarity from male attendants.
- Hand dryers and user feedback machines should be situated in the female block in locations that afford the user some privacy.

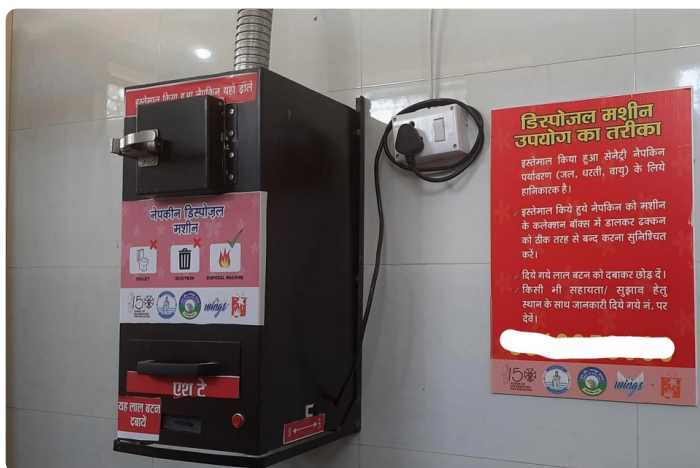
► Photo 3:

An incinerator for menstrual waste in a community toilet

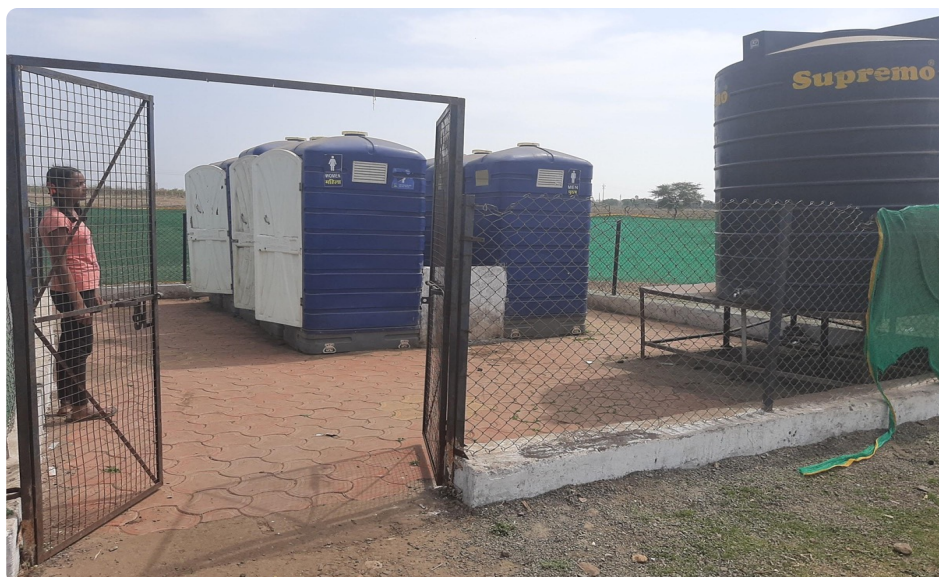
► **Photo 4:**  
One of the  
assessed  
community  
toilet facilities

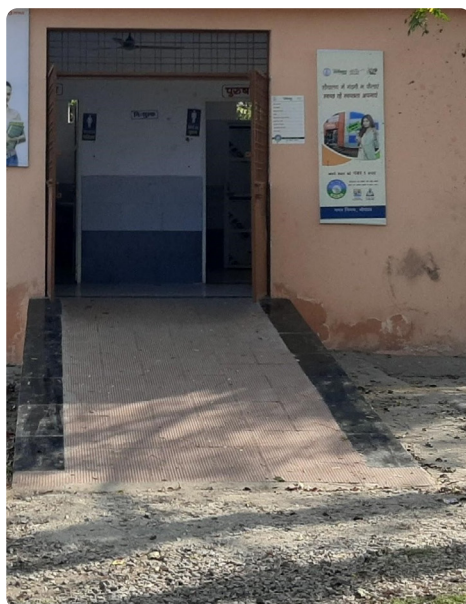
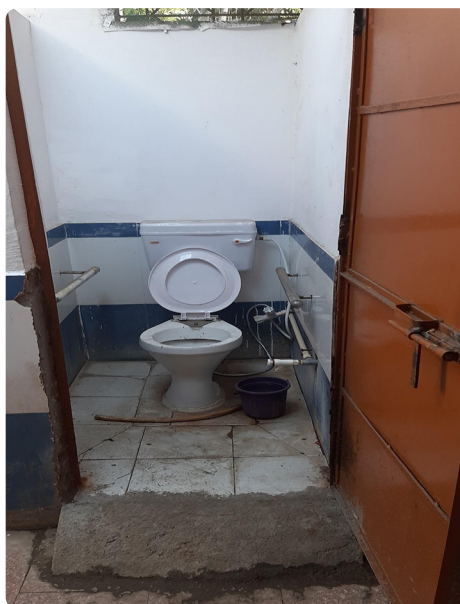
► **Photos 5-6:**

A ramp to the entrance of a community toilet and the accessible toilet in the female section of a public toilet with handrails, a seated toilet and an outward opening door

- Ensure that all toilet facilities have **accessible toilet cubicles** in the female blocks or in common areas.
- Make sure that the cubicles for people living with disabilities can be used by **wheelchair users** and also take into account a range of other disabilities and difficulties.
- Consider **tactile signage** throughout facilities.

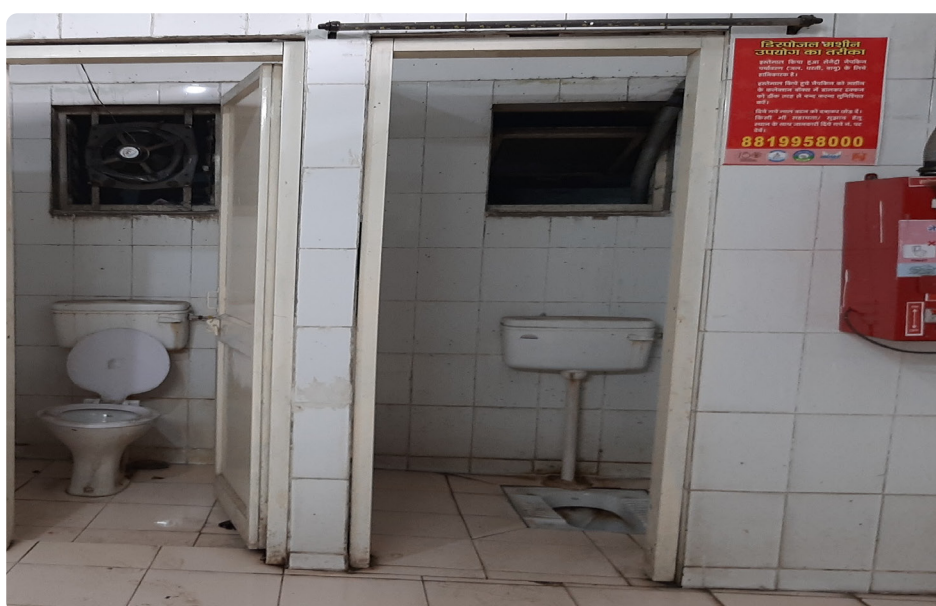
► **Photo 7:**  
Female cubicles including a squatting cubicle without a door

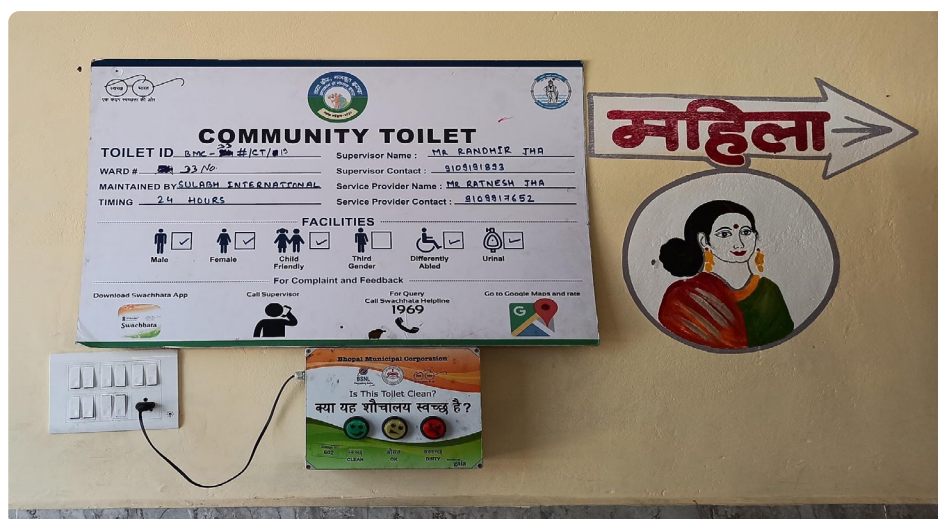
► **Photo 8:**  
A digital feedback device in a community toilet

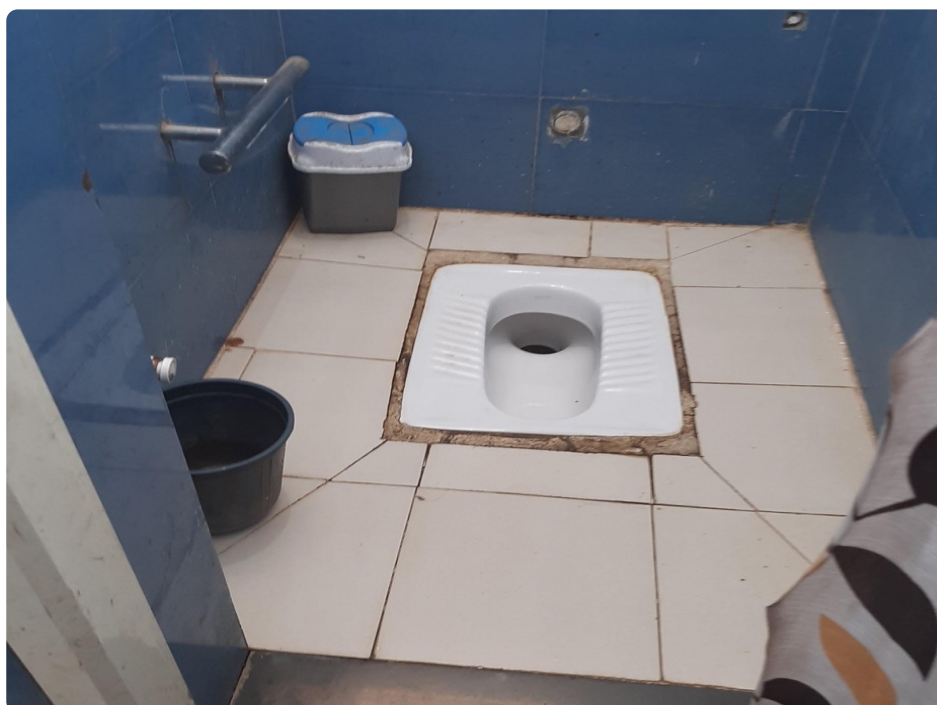
All the community toilet facilities and most public toilet facilities had a cubicle for children. In all the sites visited, the toilets labelled as ‘child-friendly’ were exactly the same as other toilet cubicles in terms of design, accessibility and features, with the only difference being that these had a curtain instead of a door (the rationale was that children find it difficult to lock and unlock the door from inside, hence a curtain makes it ‘child-friendly’). Much fewer toilets had a child-friendly handwashing station, and where they did exist they were usually in the common area. The handrail in the children’s toilets were often not in a useful position for squatting over the toilet (see Figure 7).

► **Photo 9:**  
A cubicle designated for children in a community toilet block

- **Child-friendly doors** for child-friendly toilet cubicles should be installed instead of curtains, which were found to compromise privacy and make children feel embarrassed. Also, these cubicles should have child-friendly toilet seats suitable for children.

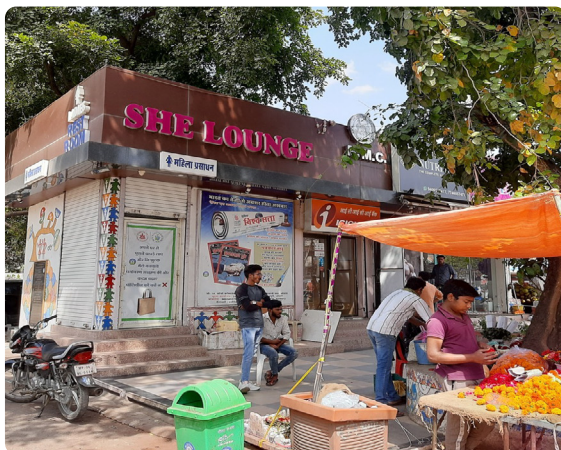
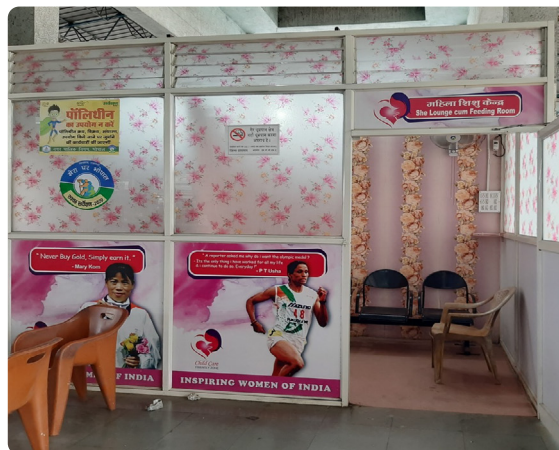
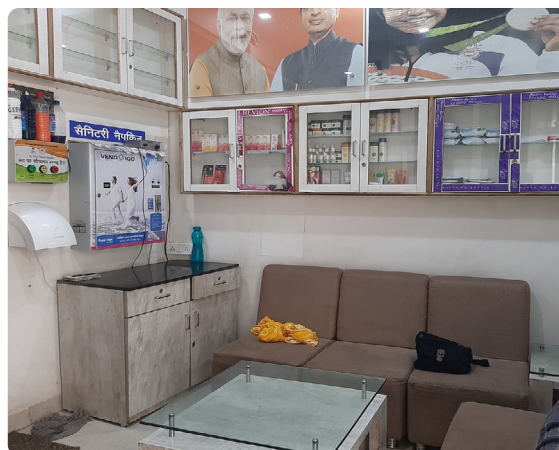
### She Lounge

The 'She Lounge', managed by the City's Municipal Corporation, was not included in the assessment alongside the other facilities, which were all managed by a third-party service providers. The She Lounge serves as a model not only for a female-friendly space with proper and feasible access to restrooms, but also as a secure space for women's comfort and preference. There are currently three She Lounge facilities in the city out of a planned 14. They were constructed to cater to the needs of women who work in the market and those come to shop.

Importantly, whilst the manager of the facility was male, the lounge was run on a day-to-day basis by women with the caretaker and cleaner also being female, making it feel like a safe space for female users. Many users use the space three to four times a day, even just to have some relaxation time. The lighting was good inside and outside the lounge at the time of observation. The lounge had exhaust fans for ventilation.
