# Female-friendly public and community toilets in Tanzania: an assessment in Babati Town

May 2022

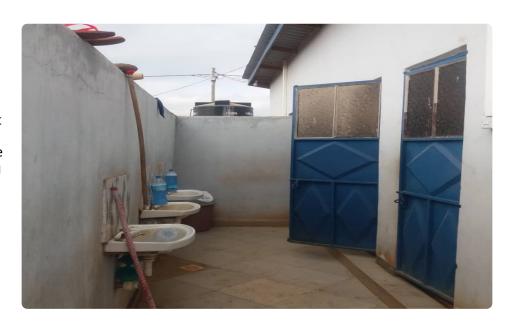
#### Photo 2:

The cubicles of toilets with solid doors to ensure safety and privacy at Maisaka main bus stand (the hand washing stations are outside the cubicles on the corridor)
