# Status Report on Female Friendly Public Toilets

*Kathmandu Metropolitan City, Lalitpur Metropolitan City,  
Kritipur Municipality and Madhyapur Thimi Municipality*

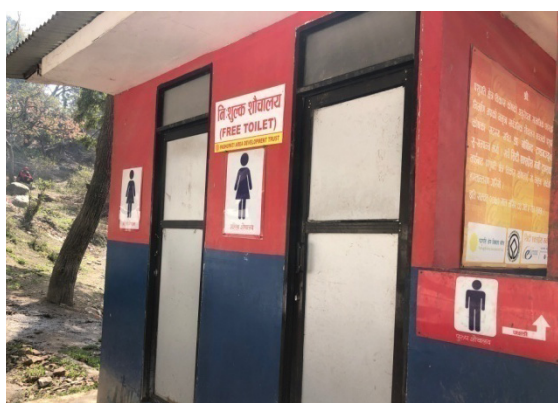
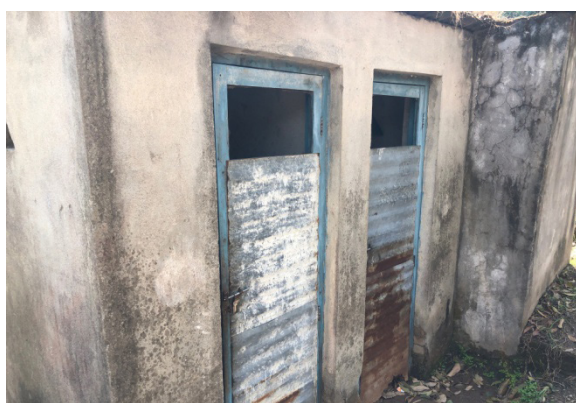
Figure 2 On the left, toilet with proper signage and sturdy door and on the right, toilet with no signage, flimsy door with an opening at the top

1. Follow up on standards of signage with pictures separating male and female toilets clearly and ensuring that signage is clearly visible and not distorted.
2. Develop mechanism which ensures lighting system works all the time
3. Tiles on the floors need to be wiped out and dry rather than cleaned with water with detergent
4. Make operators accountable to check and replace door locks if broken.

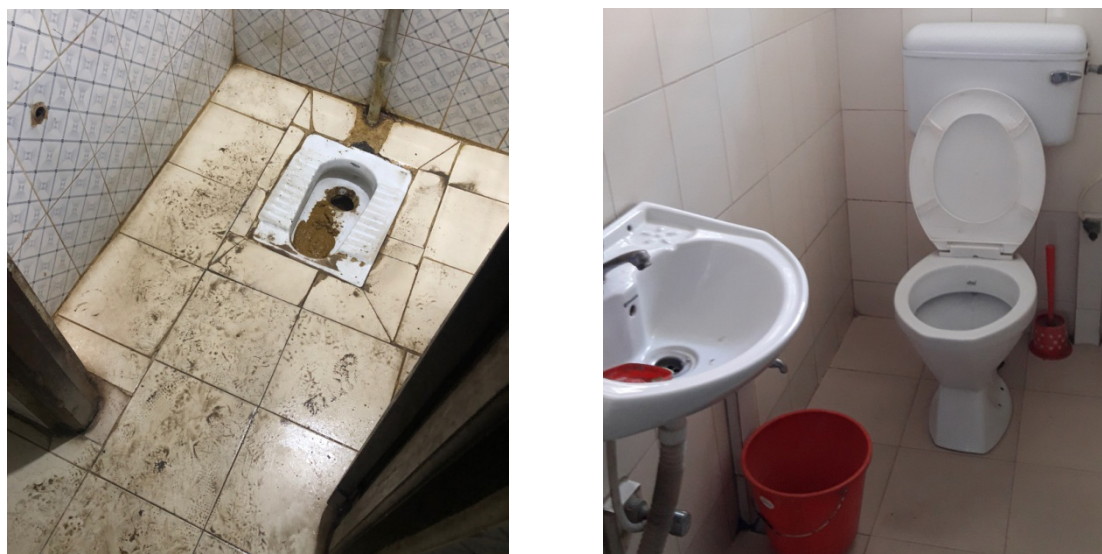
**Figure 3** On the left, a dirty toilet and on the right a clean toilet

The table 3 suggests that operation and maintenance parameters are far below the standard reaching to the level of bad. It is recommended that clear conditions on operation and management of the toilet, which is currently lacking, be included in the contract when signing the lease for the toilet. It is also recommended that monitoring mechanisms be put in place to ensure that the conditions are being met.

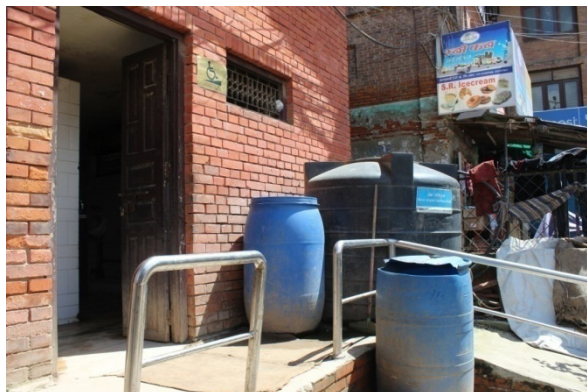
The above table suggests that 75% of the toilets have bad or very bad water supply and only the top 25% have an only okay level of water supply. During field observation it was discovered that the toilets used water extracted from boring as far as possible and if water from boring was not available; the operators would buy water from tankers. If the operators had to buy water, they also showed a slight reluctance to use said water and were prone to be frugal in water use.

Fecal waste disposal has a similar status with frequent problems in toilets relating to pipes and sewerage system.

Figure 4 Toilet with water storage outside the toilet block rather than inside cubicles and tanks blocking the wheelchair ramp

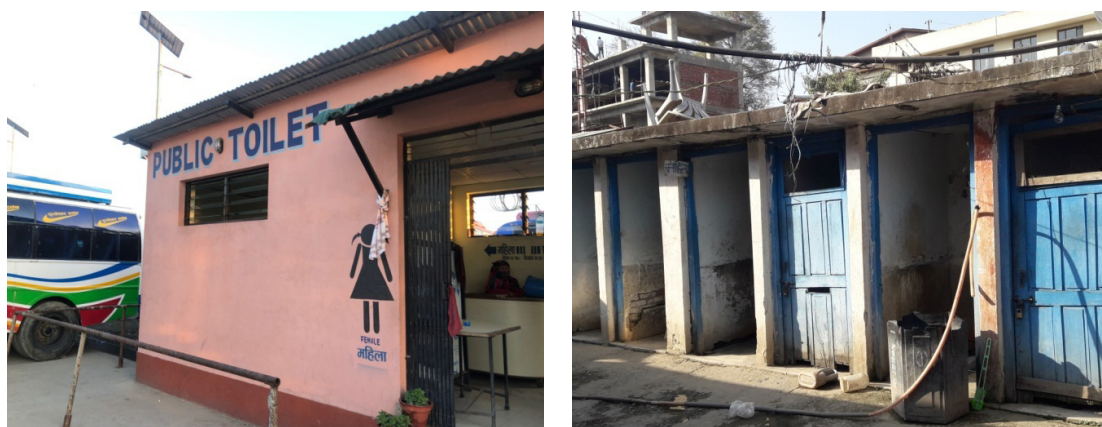
Table 6 suggests that almost all indicators have a score of 1, which implies that the majority of the toilets have no female friendly environment. It shows that only 25% of the toilets have the privacy of the female user maintained while using the facility. Similarly, only one-fourth (25%) of the toilets have a designated female caretaker. All the remaining indicators (number of female cubicles, mirror and the positioning of the mirror) score badly. Majority of toilets don't have number of female cubicles more than number of cubicles for male. Almost all toilets management is run as a family business, so separate female care taker for female units is not observed. This is true for either type of toilet—that is be it male unit or female unit, the care taker member can be male or female or children (boys or girls) on rotation basis of family members.

Figure 5 On the left a toilet with signage indicating female toilet and a female attendant and on the right, a toilet with no signs and no privacy for female users

It is suggested that initiatives be taken for creating female friendly environment in public toilets. The specific recommendations are as follows:

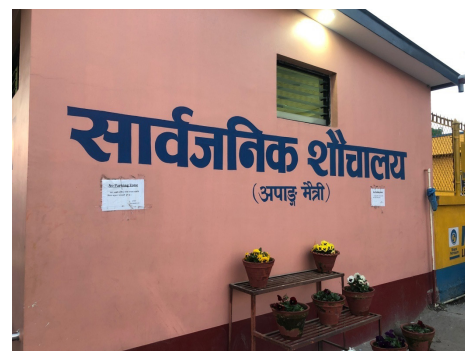
In the above table, none of the cell values in the following table have value 2, which implies that almost all public toilets have not met the basic standards of disability. During our field observation, it was found that only 12 of the public toilets had a disabled friendly toilet in their complex

and of those 12 toilets, only 2 met all the specified conditions required for disabled friendly toilets. Even in toilets with disabled friendly features, there were problems such as having drums or other obstructions in the ramp or disabled pathway, lack of water in some disabled toilets. Many of the disabled toilets were also kept locked and only opened upon request.

Figure 6 Disabled Friendly Toilet
