# **Status Report on Gender and Inclusion Assessment for female friendly Public and Community Toilets in Babati Town Council- Manyara region**

**August, 2020**

**Prepared By: Dr. Revocatus Machunda  
Dr. Francis Moyo  
Dr. Hoyce Mshida**

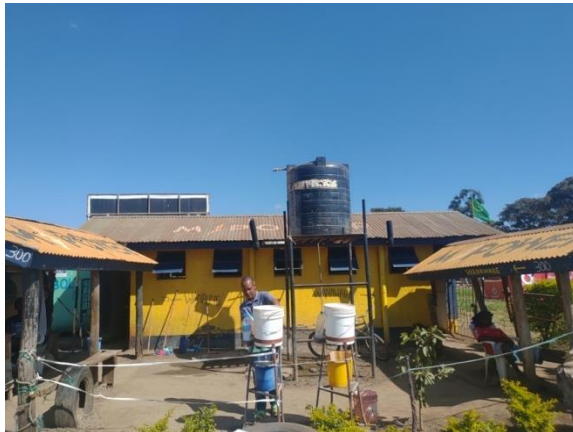
Plate 1. Public toilet at the Old Bus stand, at the Central Business District, Babati Town. (The facility has a septic tank and the faecal sludge is being emptied regularly)

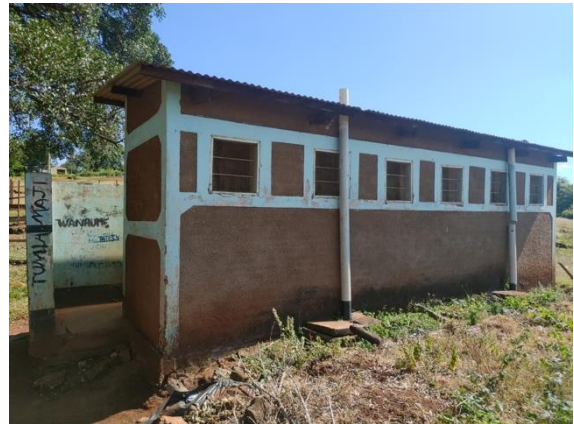
Plate 2. Public Toilet at the Gendi Market at Singe Ward. (The facility does not have a septic tank, rather it has a pit).

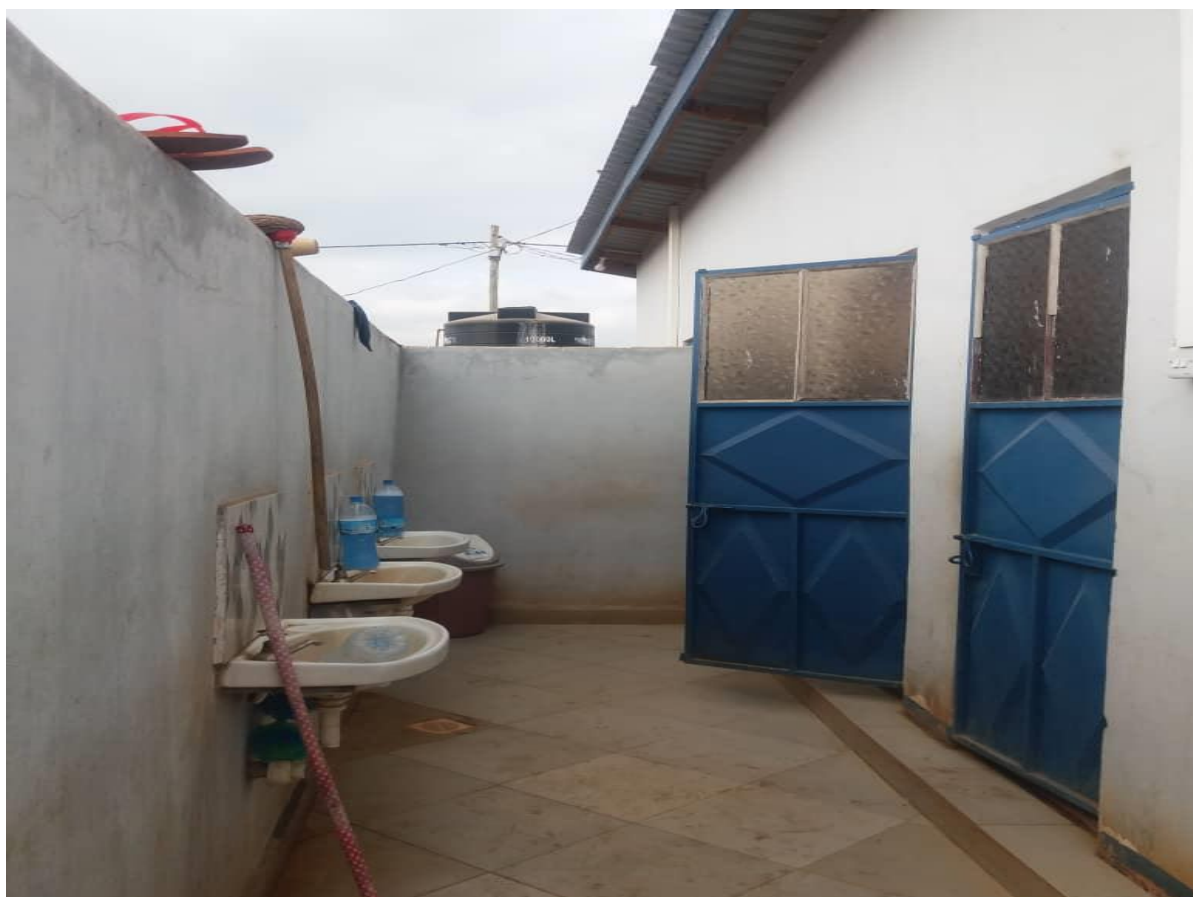
For the toilets to be female-friendly in terms of safety and privacy, certain factors need to be considered. Such factors include among others the: Location; visibility and accessibility; separate male and female units; separate entry for male and female units; clear signs that differentiate male and female sections; good lighting; ventilation; gender of attendants; and solid structures (Plate 3).

Plate 3. The cubicles of toilets with solid doors to ensure safety and privacy at Maisaka man bus stand. (The hand washing stations are outside the cubicles on the corridor).

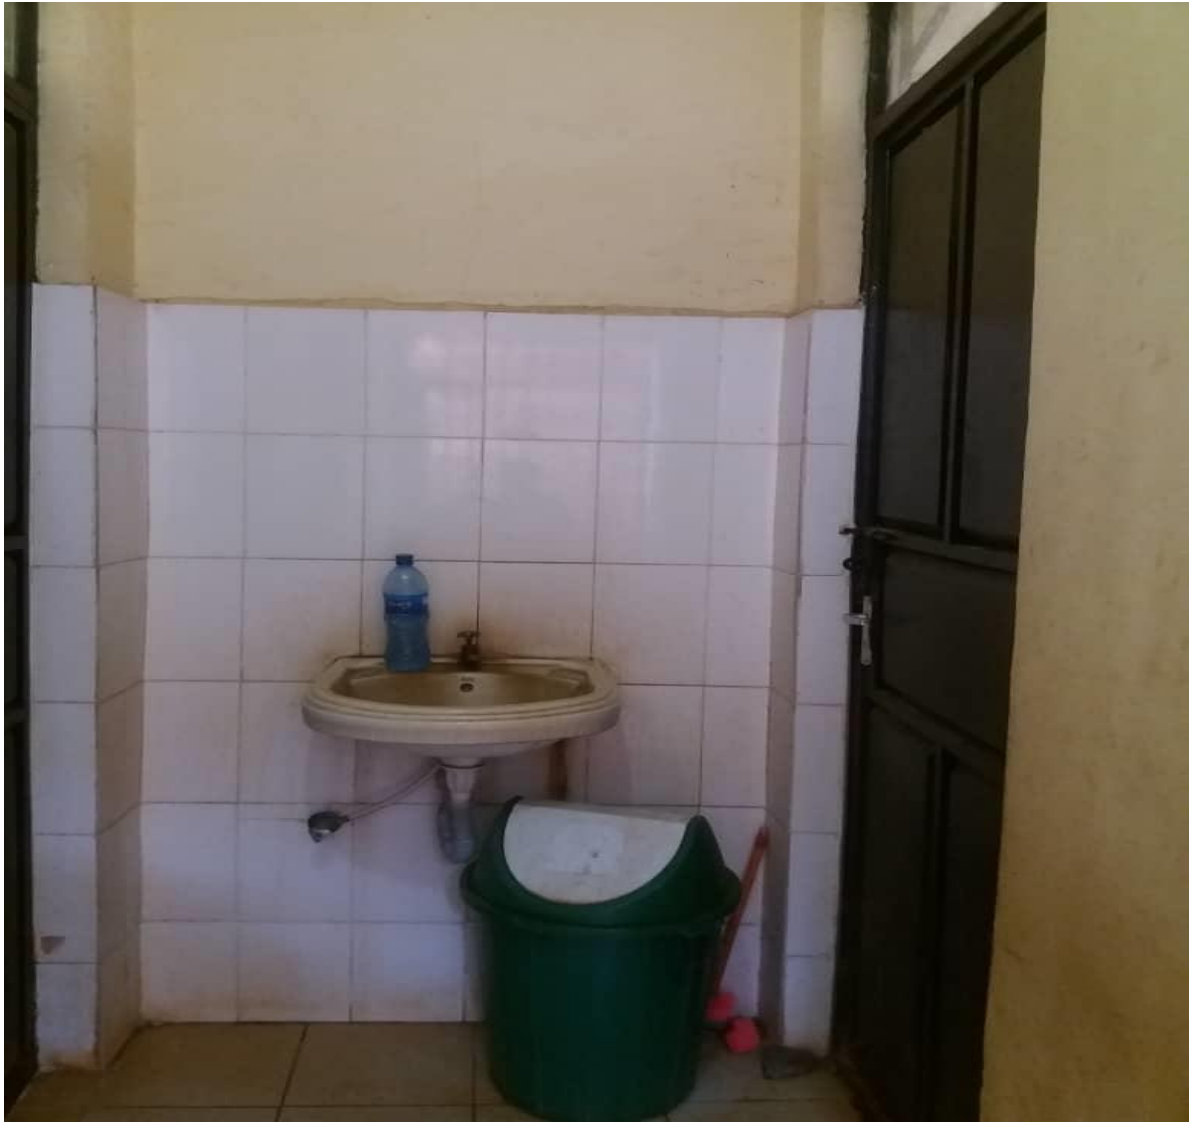
The assessment revealed that the public and community toilets in Babati Town Council did not have menstrual products in a visible place, however several shops for most of the toilets were around in a walking distance of not more than 30 meters for those in need of the products to buy them. Also, there were no hooks and ledges for keeping clothes off the floor. Only the toilets at the main market had mirrors at the handwashing taps, while the rest did not have mirrors. Waste bins for keeping the menstrual products were not located inside the cubicles, rather they were found along the corridors where mixed wastes could be thrown (Plate 4).

Plate 4. Waste bins placed outside the cubicles at the main market toilet facility (The waste were used for all types of waste, there are no mirrors).

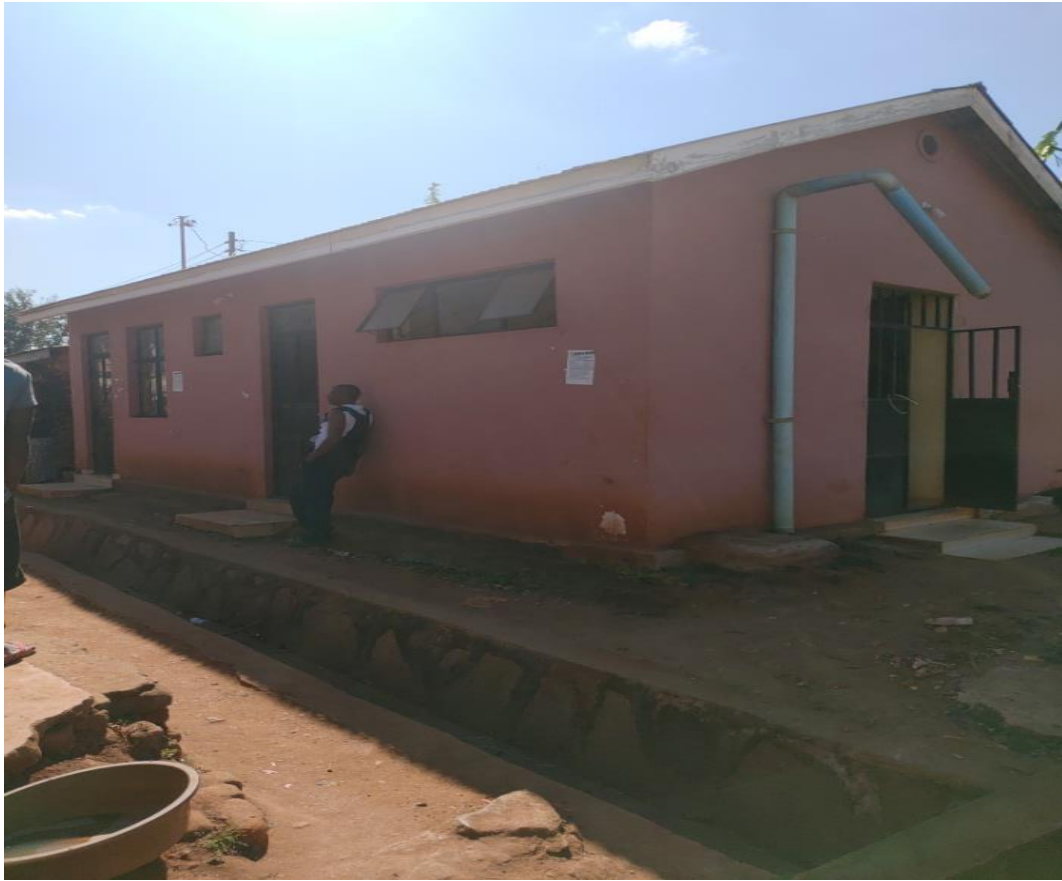
Public and community toilets affordability and availability is another important aspect that was considered when carrying out the assessment. This aspect considered the following: affordable fees; equality in use fees; opening and closing displayed for the public/user to see; and the number of toilets cubicles. A female friendly public and community toilets will have these features appropriate for users. All public and community toilet facilities in Babati Town Council can be categorised as average (Table 6 **Error! Reference source not found.**). However, it was observed that for all the toilets assessed, the number of female and male cubicles were equal. This therefore contradicts with the fact that females usually will spend more time and need more cubicles to ensure that all are served within the shortest time (Plate 5).

Plate 5. The number of cubicles for male and females were the same at the main market at mjini kati.

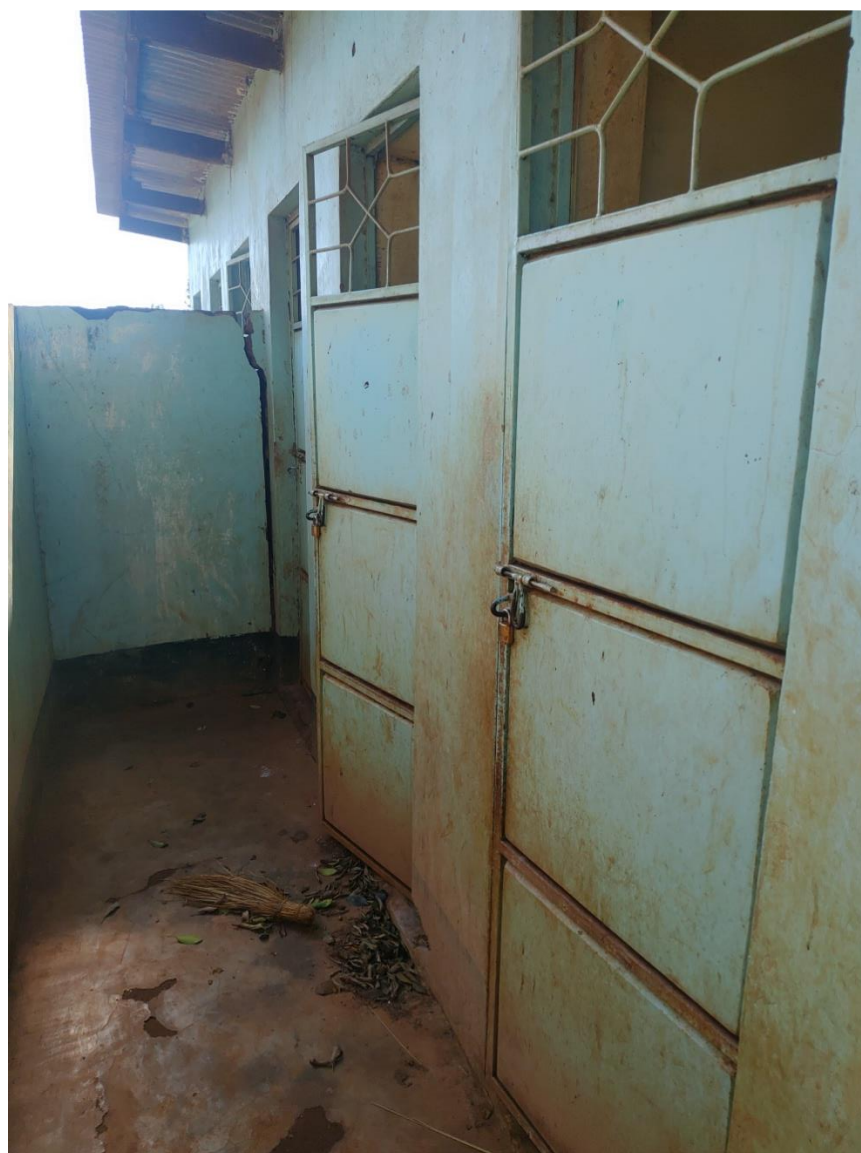
Plate 6. Visible rubbish and poor maintenance seen at Gendi market toilet facility. (The open twice per month, and the toilets is only cleaned when the toilet is operational).
