FROM SOURCE TO TAP:

IMPROVING WATER SUPPLY IN LAHAN, NEPAL

LEARNINGS FROM THE BEACON PROJECT

November 2020

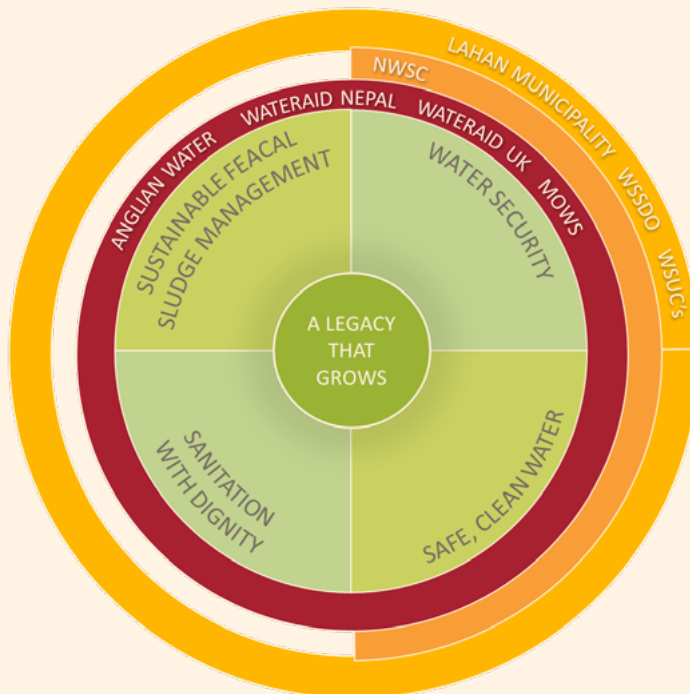
BEACON OUTCOMES 2020–2030¹

The above wheel shows the outcomes the project intends to achieve in the centre with the accountabilities for each outcome shown in the outer rings. The central outcome of a legacy that grows is shown in the middle, as each of the other outcomes contributes to this outcome.

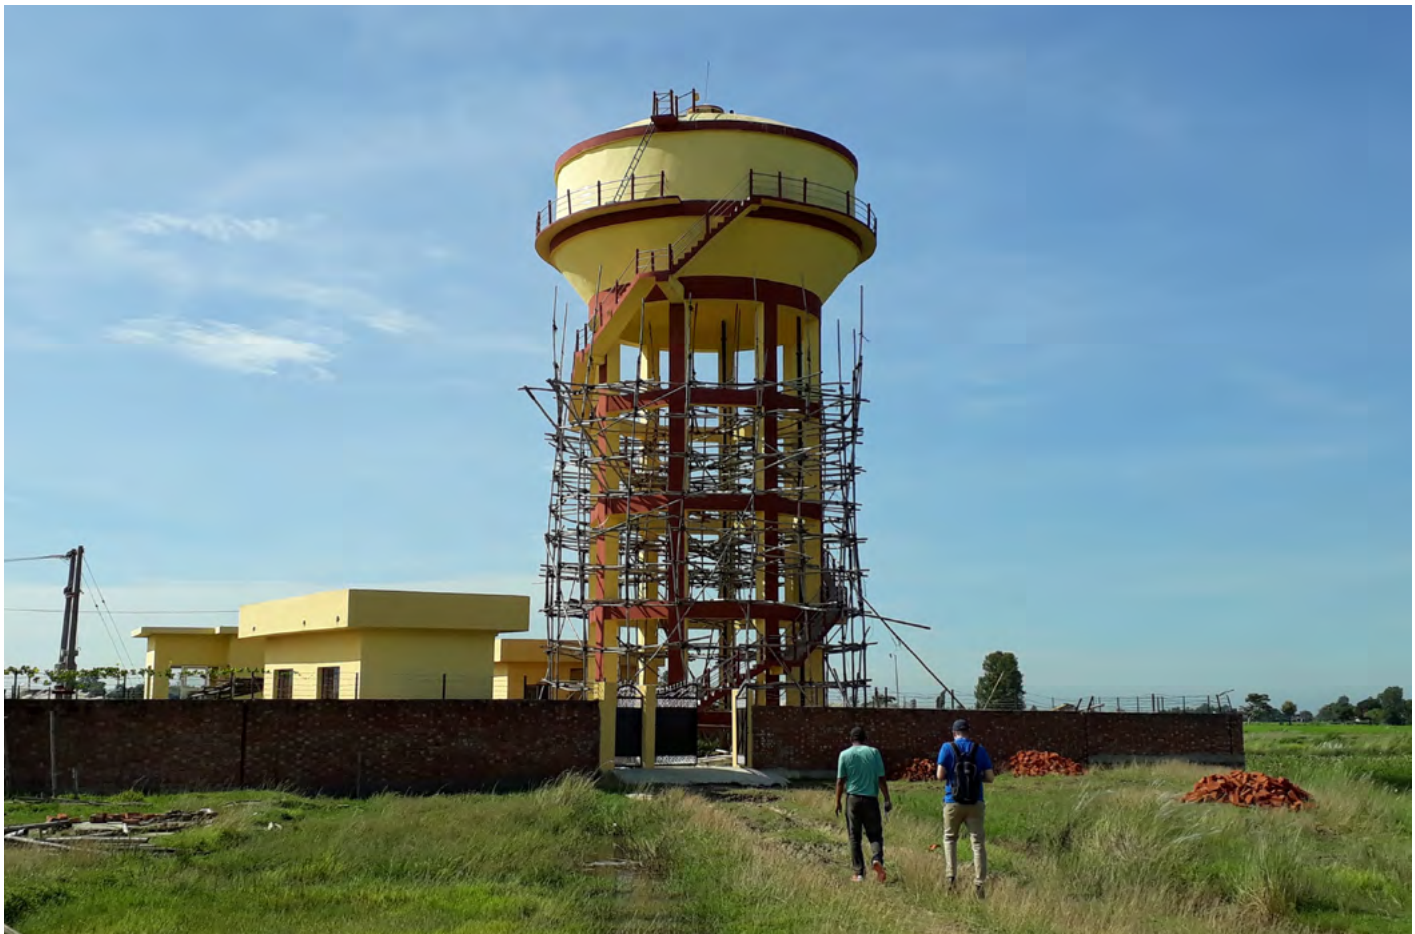
Completion of the water tower in the new NWSC compound (2018).

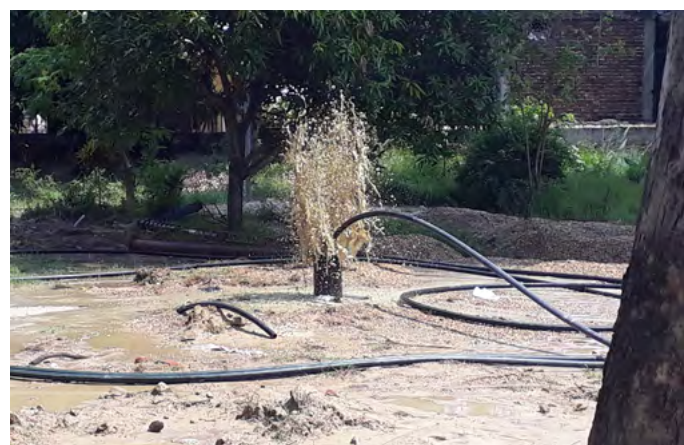
Using an air compressor to complete the development of BH7.

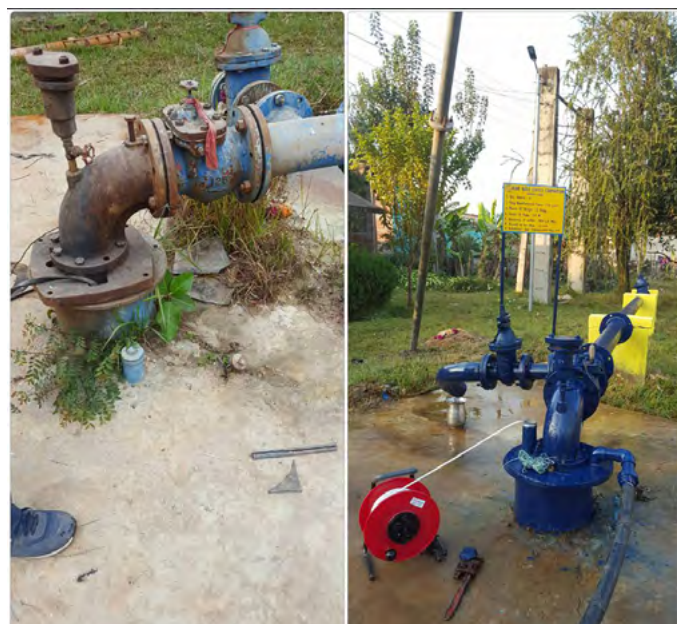
Before and after replacing borehole head plates.

As a quick win, the project provided technical support to protect existing boreholes – replacing the borehole head plates to prevent surface contaminants entering the boreholes (for example, see the before and after photos below) and constructing a protective shed around the borehole in the marketplace. Where the borehole is of sufficient diameter, a monitoring shaft was fitted to facilitate groundwater monitoring.

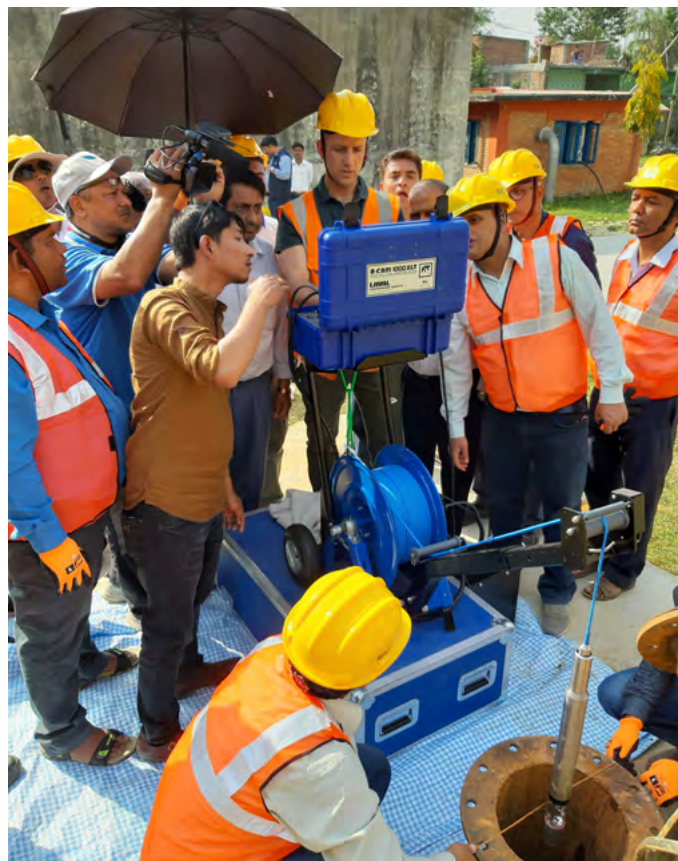
CCTV survey training by Anglian Water.

Another key intervention was to conduct camera inspections of these boreholes – these surveys provide important information on the condition and performance of a well or borehole. CCTV camera surveys conducted immediately after the construction of boreholes provide a useful benchmark against which to monitor the condition during future routine inspections.

NWSC Lahan revealed cracks in the borehole casing and inappropriate screen selection – which may have contributed to the sand ingress. Most of the functional boreholes were already more than half filled with sand and in immediate need of air-lifting. The direct experience of observing the state of these boreholes made a real impact on the NWSC staff and brought home the importance of proper borehole drilling and construction. Following the training, the CCTV camera unit procured by the Beacon Project was handed over to NWSC, and has been in regular use since, not only in Lahan, but also in nearby NWSC branches.

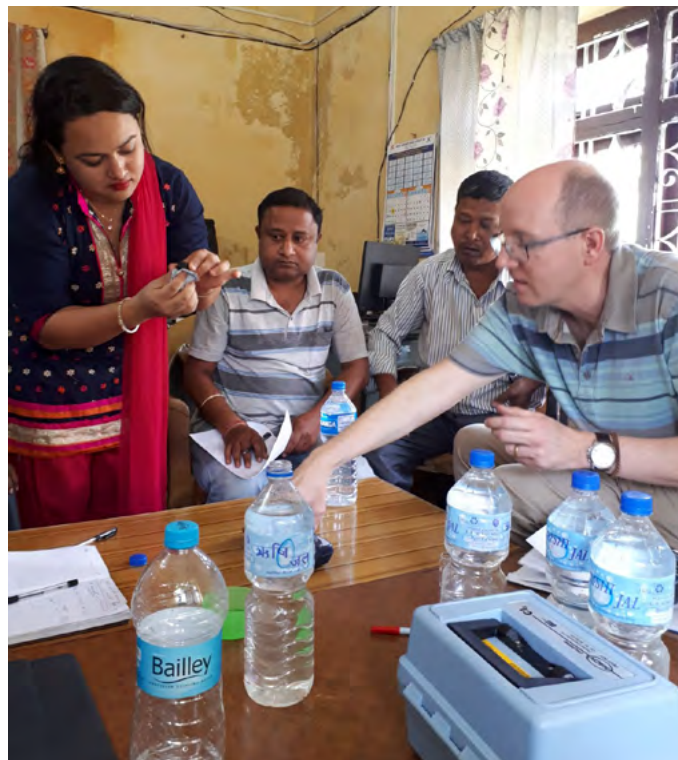
Water quality test being conducted at NWSC.

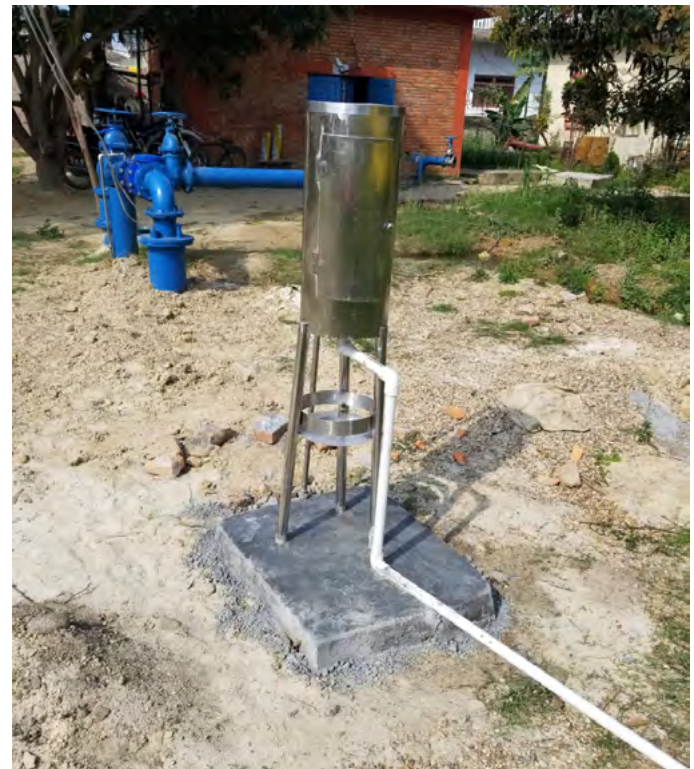
Borehole sampling tap installed in NWSC Lahan.

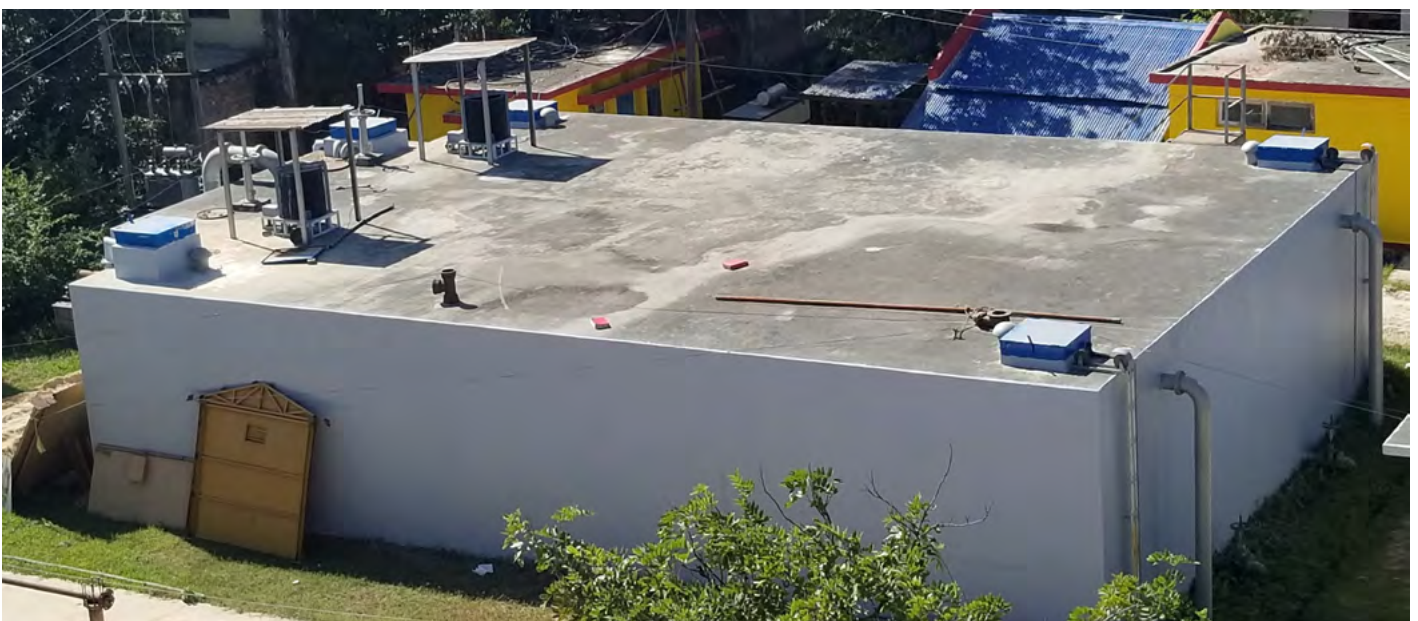
Rehabilitated sedimentation tank with the new hatch covers.

At the boreholes, testing has been carried out to monitor the turbidity at reduced flow rates in order to minimise the fine sand being pumped. However, current demand in the network with the existing boreholes means there is not much scope to reduce the pumping rates. The sedimentation tank was manually emptied to remove large deposits of sand that had built up, and the washout on the overhead storage tank is now used more regularly to flush out this tank before it enters the supply. Anglian Water also advised NWSC on the specification for hatch covers, and these have been replaced on the sedimentation tank (see photo) to prevent ingress of rainwater, bird faeces or vermin.

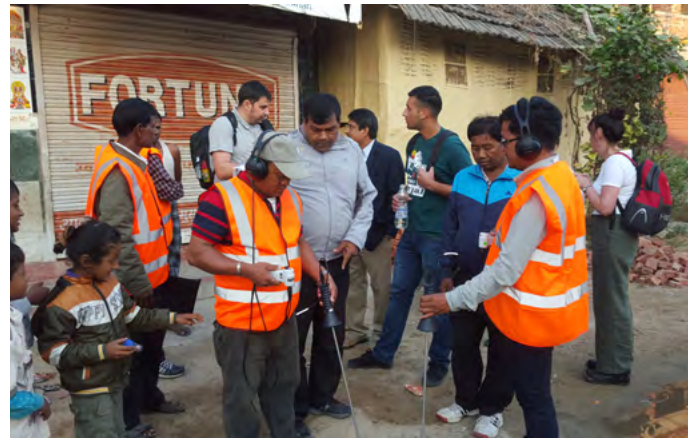
Leakage detection training.

In 2017, a mapping of NWSC Lahan's existing pipe network in GIS platforms was initiated with support from the Beacon Project. In November of the same year, a leakage detection training using listening rods was provided to seven participants from six NWSC branch offices, including Lahan, and two participants from WSSDO. Eight leakage detection equipment kits were procured, out of which two were handed over to NWSC Lahan, five were handed over to other NWSC branch offices, and one unit was kept in the Beacon Project office.

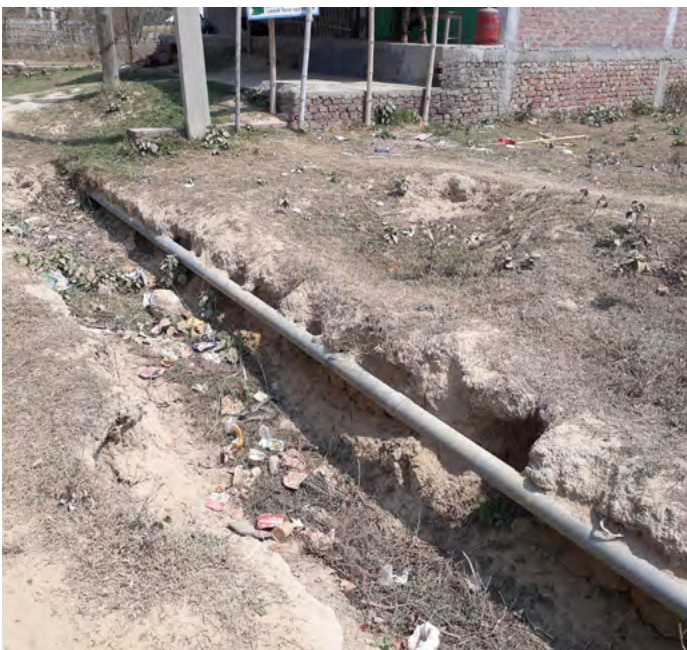
Damage to pipes due to the shallow depth.

There are two major problems contributing to NRW in Lahan. One is a high rate of leakage in the piped network leading to physical losses. Leaks may be caused by poor construction (for example, poor quality joining), corrosion of old pipeline, mechanical damage (particularly where pipe has been installed at a shallow depth – see photo), or damage to valves, meters or other fittings. Many leaks remain undetected, and the water lost through them after treatment and pressurisation represents wasted money and energy that adversely impacts the sustainability of the whole system. Furthermore, leakage points are a potential health risk as they can be entry points for secondary contamination. This is particularly the case in a network with intermittent supply as there are regular drops in pressure, so contaminants can easily enter through any leakage points.

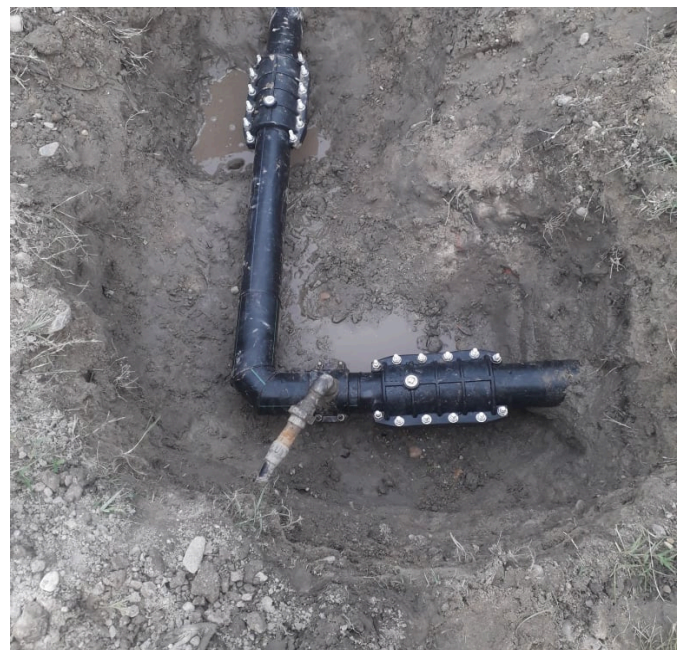
Leakage repair and household connection.

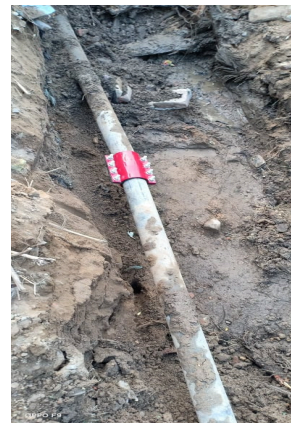
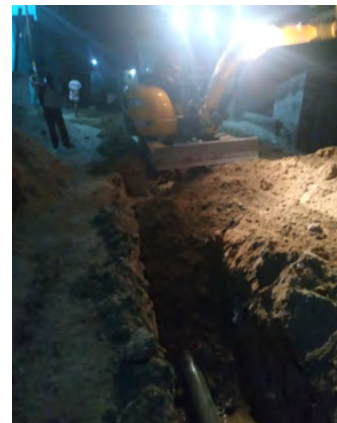
Repairs to the network being carried out by NWSC.

Based on this training, NWSC Lahan worked on repairing all visible leakage as an initial step to reduce physical losses. With proper recording of the leakages repaired, a heat map of the entire network was generated which identified hotspots for areas with leakages (see Figure 8). This has been a great tool to identify potential areas for the non-visible leakage detection and repair programming.

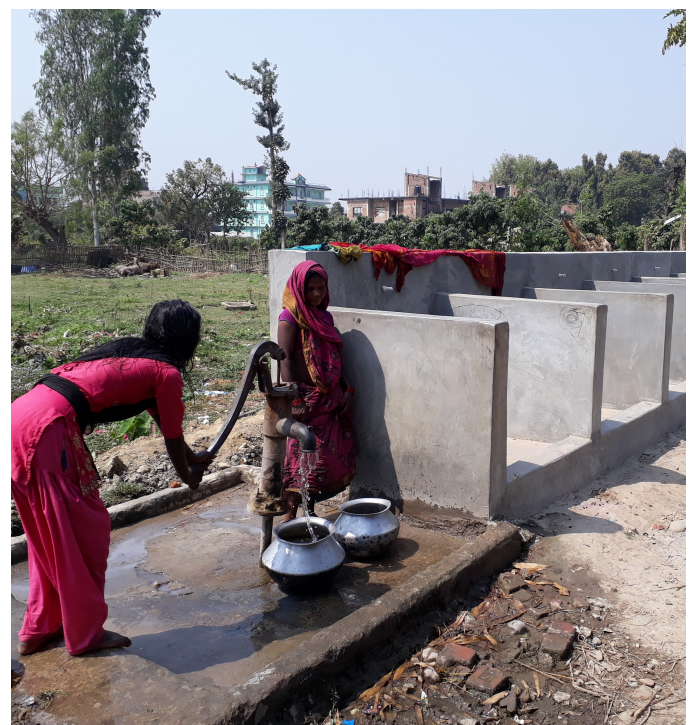
New tapstands being constructed to replace the communal handpump.

One of the major targets of the Beacon Project is to bring 24/7 water supply in wards 1 to 10 of Lahan municipality. In line with this ambition, community consultations were carried out in the Dalit communities to understand how they could be brought under 24/7 coverage in a sustainable way. These consultations revealed that given the connection costs and monthly tariffs, a 'One House, One Tap' approach would eventually create an unsustainable economic burden for a household. Instead, community members opted for a shared tap, where they could divide the connection charge and tariff among multiple households.
