New Sanitation Technologies for Communities with Poor Soil

Technical solutions for areas with shallow groundwater and frequent soil collapse.

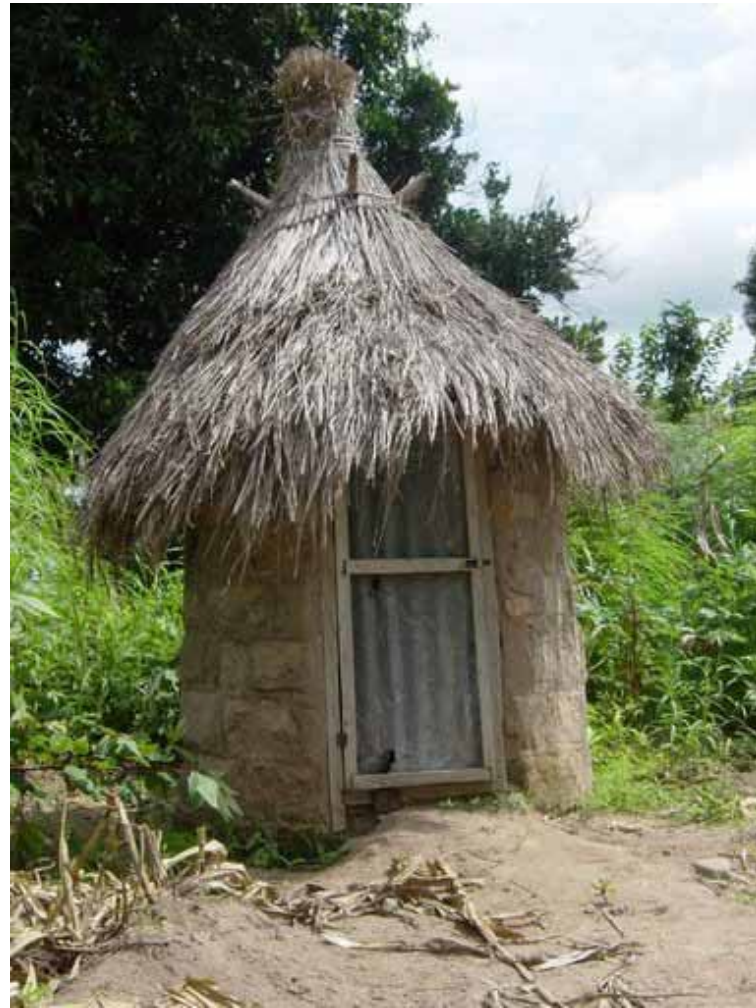
A typical pit latrine in Benue State, Nigeria

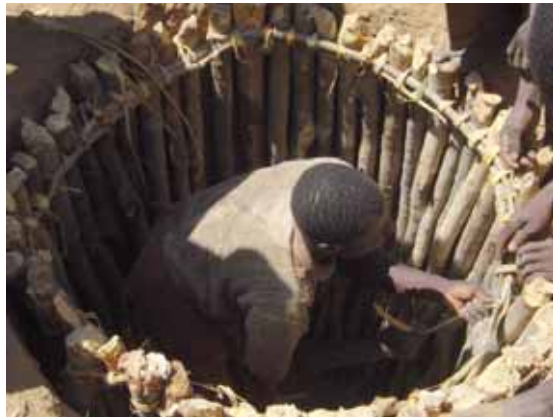
Local artisans secure a flexible hoop at the top of a hardwood pit in Balzur Community Tafawa Balewa LGA, Bauchi State (left), The cage is subsequently encased in mud treated with latrite and a collar beam is formed at the top.

those that naturally develop in bamboo cages. As a result, the clay packing becomes increasingly critical. If available funds exist, bitumen can be added to increase the resilience of the packing material. The installation procedure of the hardwood lining is similar to that of the bamboo option indicated above.

Hardwood Lining

The scarcity of bamboo in arid regions such as Bauchi compelled the pilot project team to select alternative materials for the cage structure. Here, local hardwood sticks were substituted. Sufficiently strong, the sticks provide an adequate substitute, however their natural form is often less straight than bamboo stalks.

Voids between driven hardwood sticks are often substantially larger than

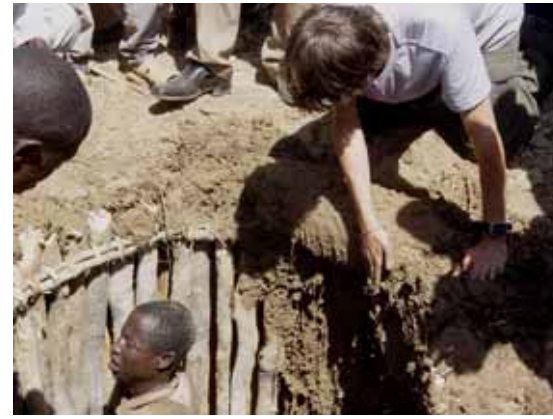
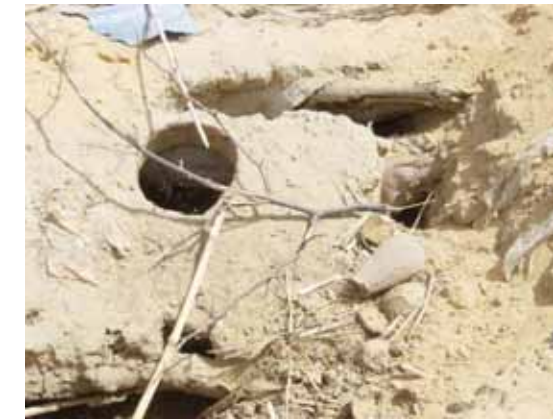
Partners and program engineers inspect a community latrine that collapsed in Benue State after a failure in the pit below (left), a collapsed pit in Jigawa State (right).

In southern states, pit collapse is most often experienced at the peak of the rainy season. The saturated soil is commonly less stable than its dry counterpart, and shallow groundwater often rises well above the pit floor. The standing water within the pit drives erosion of the unlined walls.

This erosion ultimately undermines the stability of the soil above, which sinks or falls into the pit. Any structure built above is subsequently compromised: concrete will crack and mudblock will tumble. The failure of the superstructure may occur gradually or catastrophically, depending on the composition of the soil, weight of the building materials, and extent of erosion beneath.

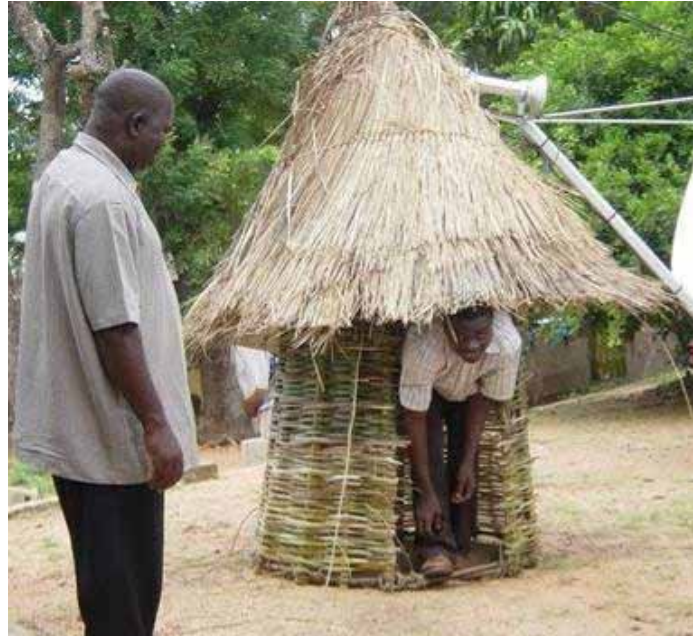
An arborloo, constructed of woven palm fronds at the WaterAid office in Makurdi.

can be introduced to any community regardless of income levels or available materials. The superstructure can be built of anything lightweight, including grasses, softwoods, bamboo, or other indigenous vegetation. In Benue, an arborloo superstructure comprised of woven palm fronds was constructed at a cost of roughly US\$12, and can serve as a household sanitation facility there for years before it needs to be replaced.

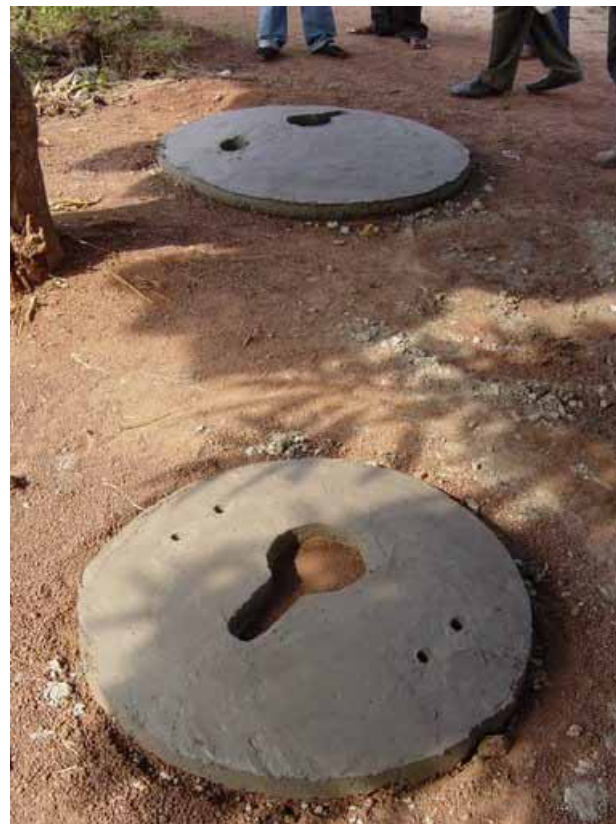
A lightweight dome slab cast in Oju LGA. Hole pairs will be used for rope handles.

Typical latrine floor slabs can also be made lightweight and portable. In cooperation with WaterAid, a local sanicenter in Benue recently began producing cement dome slabs with a diameter of 80 centimeters (in contrast to the standard 120 centimeters) to reduce its weight. Additionally, holes were cast on opposing sides of the slab to

facilitate the use of rope handles.

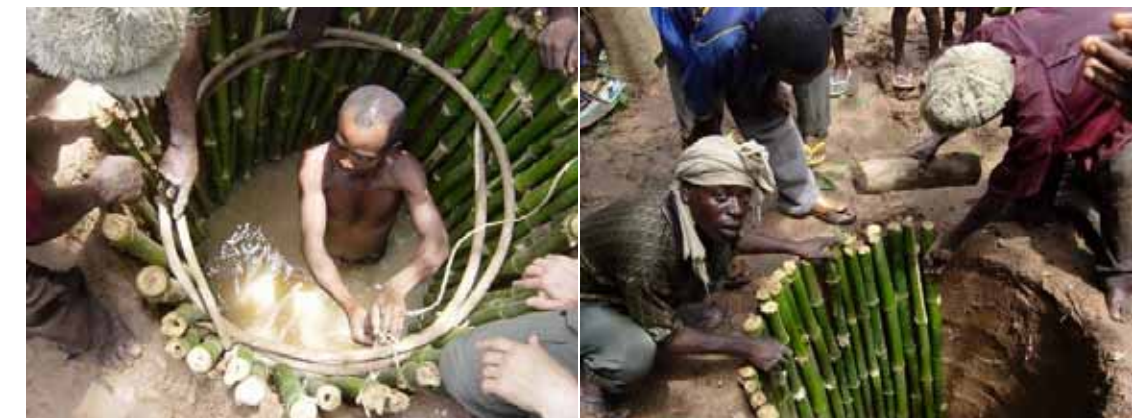
Community sanitation committee members drive bamboo rods in Obijago Community, Obi LGA (left), a softwood hoop is installed and secured with rope (right).

In Benue, the availability of bamboo led to its selection as the primary structural element. The bamboo stalks were cut to a length 25 centimeters greater than the depth of an excavated pit, and one end of each bamboo rod was sharpened with a cutlass. The sharpened end of each

rod was then driven into the floor of the excavated pit adjacent to the soil wall with a hammer, until the top of the rod was made level with the surface of the ground.

Each rod was driven individually, placed up against the previous rod driven, as the construction team moved in a concentric circle until they returned to the first rod. At the top of the bamboo cage, a piece of flexible softwood was installed as a compression hoop and tied to each rod with rope.

To ensure effectiveness of the new lining, voids between the soil wall and bamboo were packed with water-resistant clay comprised of mud and latrite. This packing serves as a barrier that stops erosion of the soil walls and protects the bamboo from termites.

The top of the bamboo cage and flexible hoop are cast into a mudblock capping beam. Once the beam has dried, a slab and superstructure can be added by the user.
